2015 Shilington – Malawi LP4x4 Deployment
Network Code: YQ
Site 110B Data Assessment

Initial observation/assessment:

Sensor-Ball 48 (containing Trillium-240 serial number 145) appears to have duplicating data on the two horizontal channels. Need to test and evaluate SB-48 (T-240 s/n 145) once it returns from Collier-Antilles deployment.

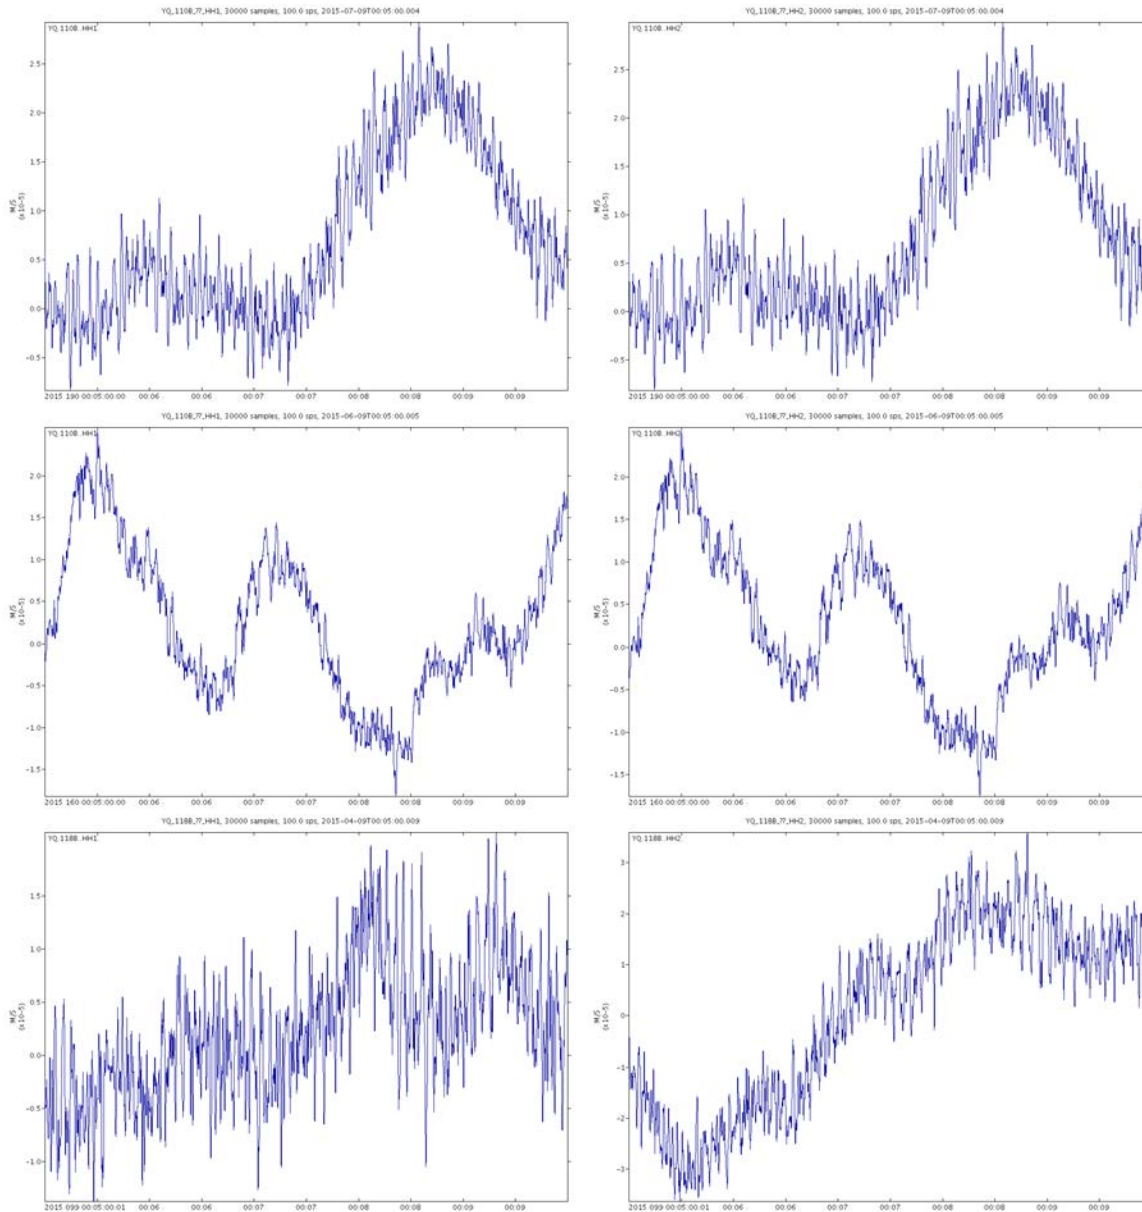
Figure 5 shows two five minute segments of data from the horizontal components of station 110B, with a five minute segment from station 118B for comparison. The 110B horizontals are not exactly identical, but they are very similar.

Upload Verification Form – Figure 5: Five minutes of recording on Station 110B Horizontals (top and middle) and Station 118B (bottom) for comparison. HH1 left, HH2 right.

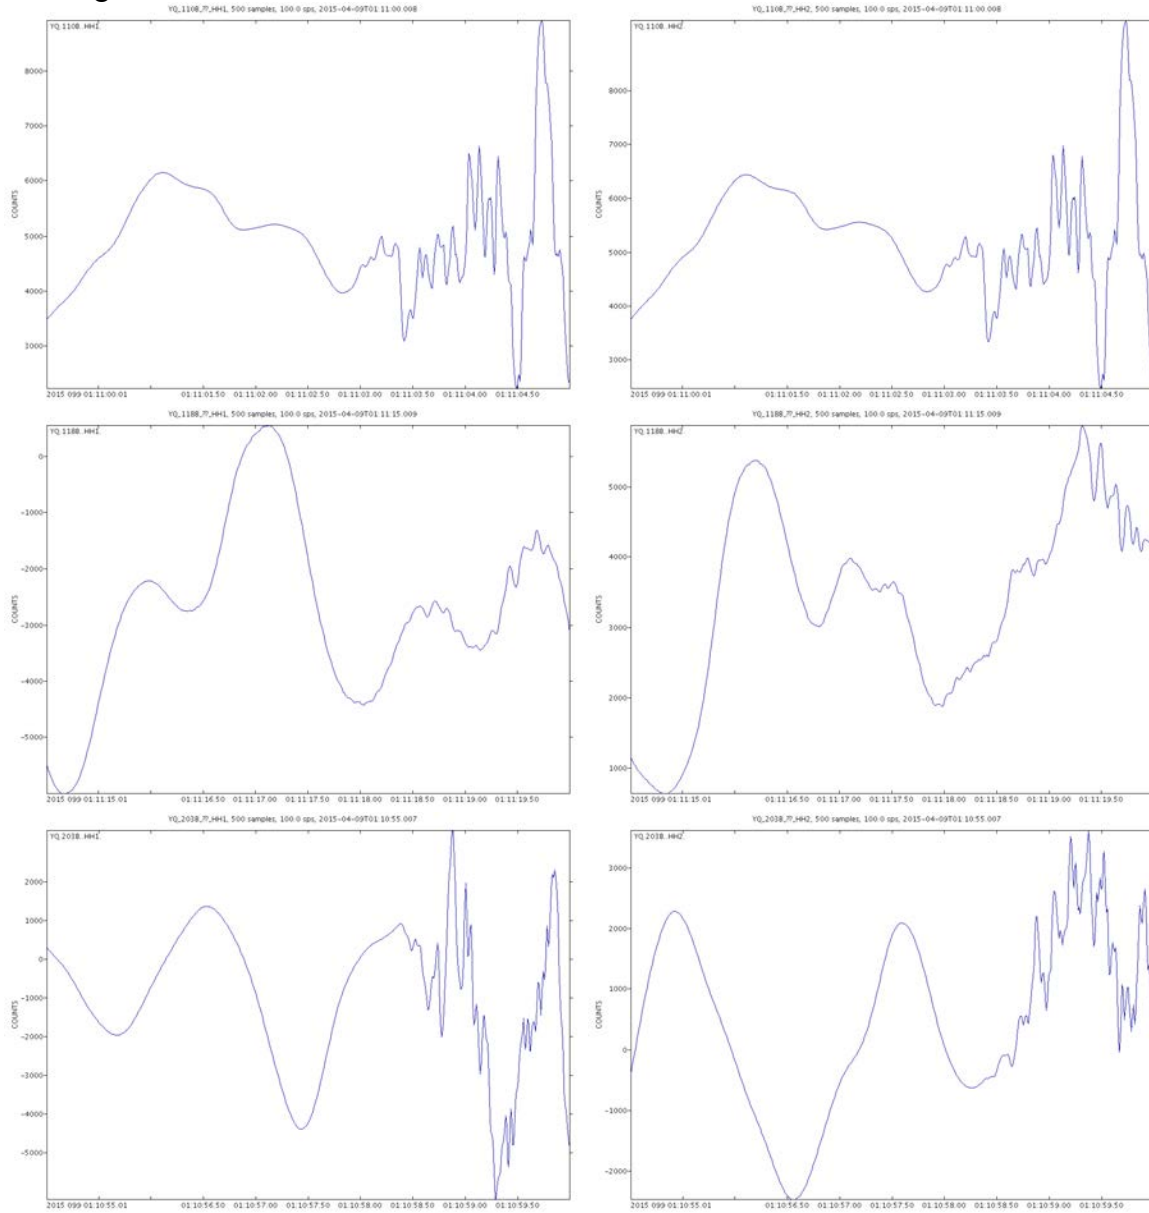
Upload Verification Form – Figure 6. Beginning (5s) of a local event on 4/9/15 on Station 110B horizontals (top), Station 118B (middle), and Station 203B (bottom) for comparison. HH1 left, HH2 right. Event was a M4.0 on 4/9/15 at 01:10:39 in Tanzania.

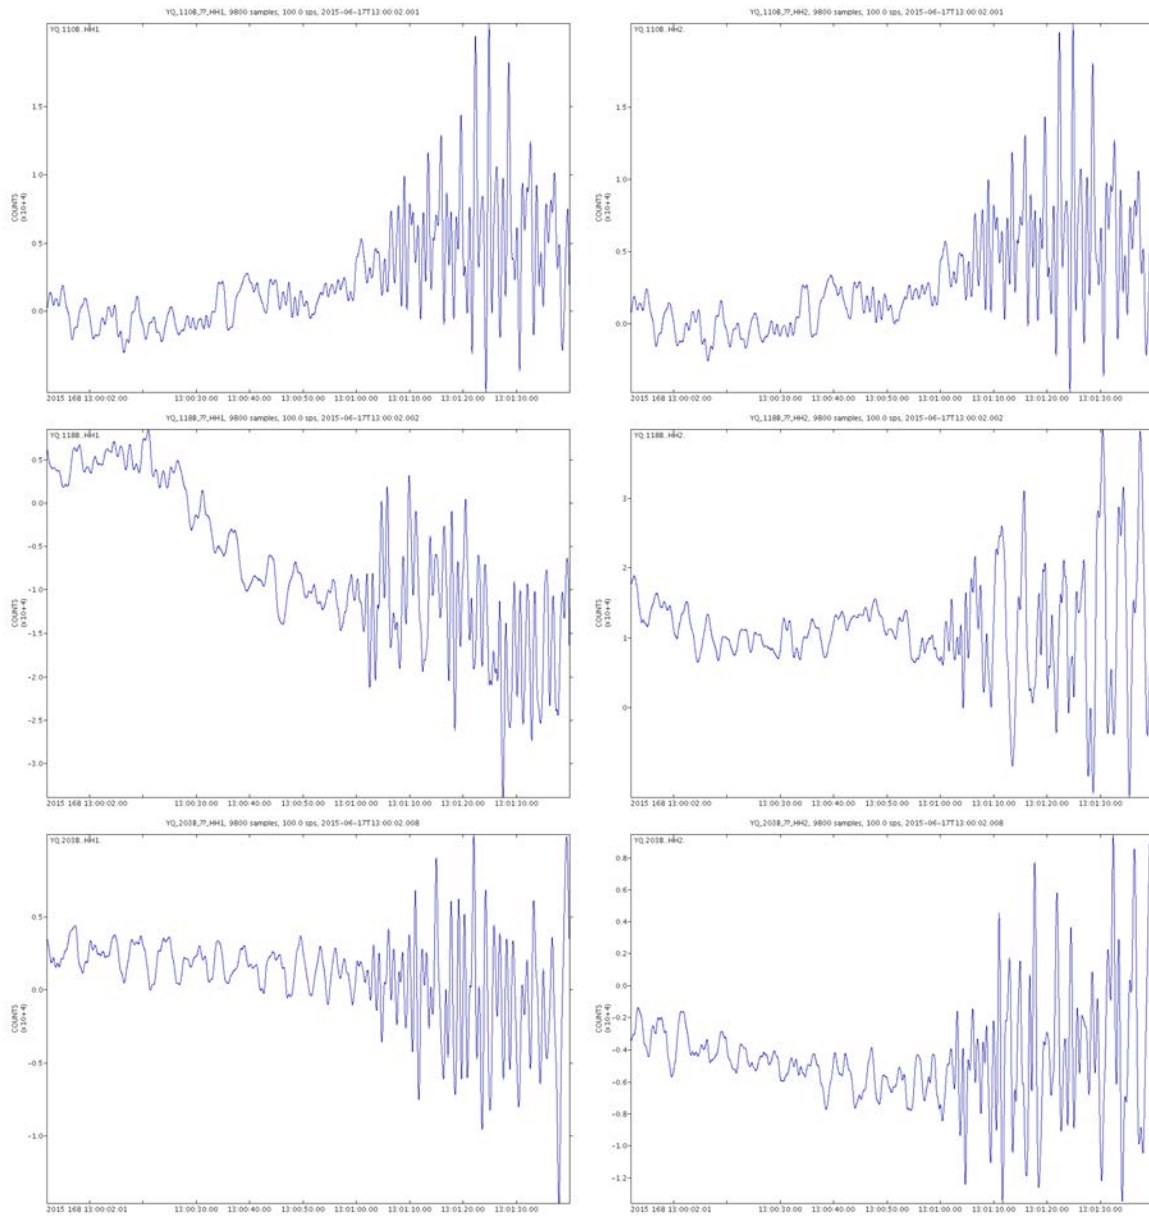
Upload Verification Form – Figure 7. Beginning (1m 40s) of a teleseismic event on 6/17/15 on Station 110B horizontals (top), Station 118B (middle), and Station 203B (bottom) for comparison. HH1 left, HH2 right. Event was a M7.0 on 6/17/15 at 12:51:32 in the South Atlantic.

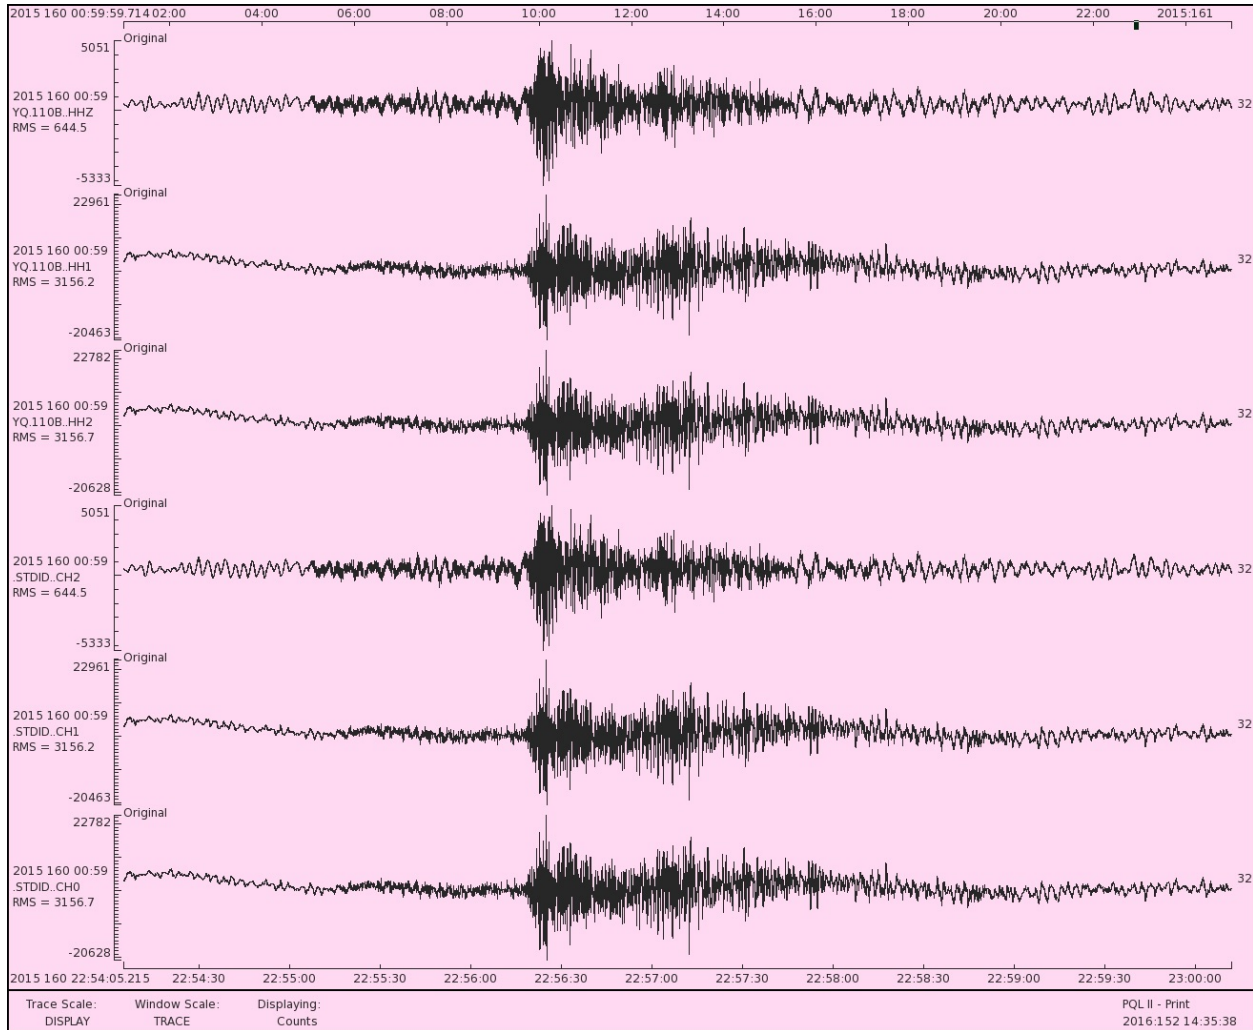
Malawi-site110B-2015-160-reprocess-comp.jpg: The bottom three traces CH0, CH1, and CH2 correspond to the X, Y, and Z components of the Trillium-240 seismometer (right-handed data). The top three traces in the above plot are the SIO archive version of “fixed” data (HH2, HH1, and HHZ) and are the identical mapping of these channels to a left-handed coordinate system. This data is subsequently uploaded to the DMC.

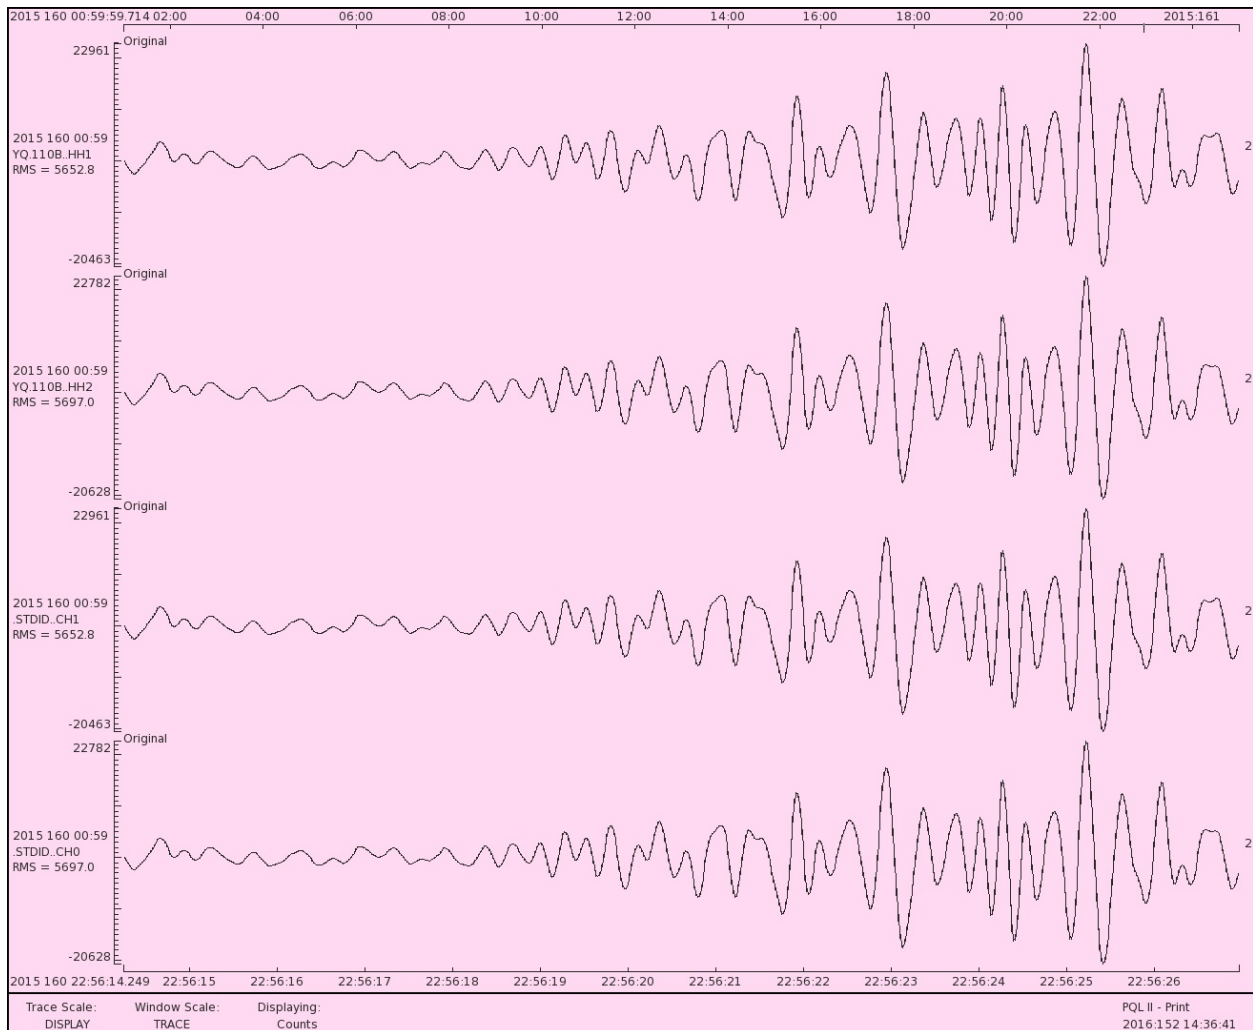
Malawi-site110B-2015-160-reprocess-comp2.jpg

A closer inspection of horizontal data for these data show what appear to be “duplicate” data in the horizontal channels, and confirm that all SIO archived data have the same characteristics as data in the DMC archive.

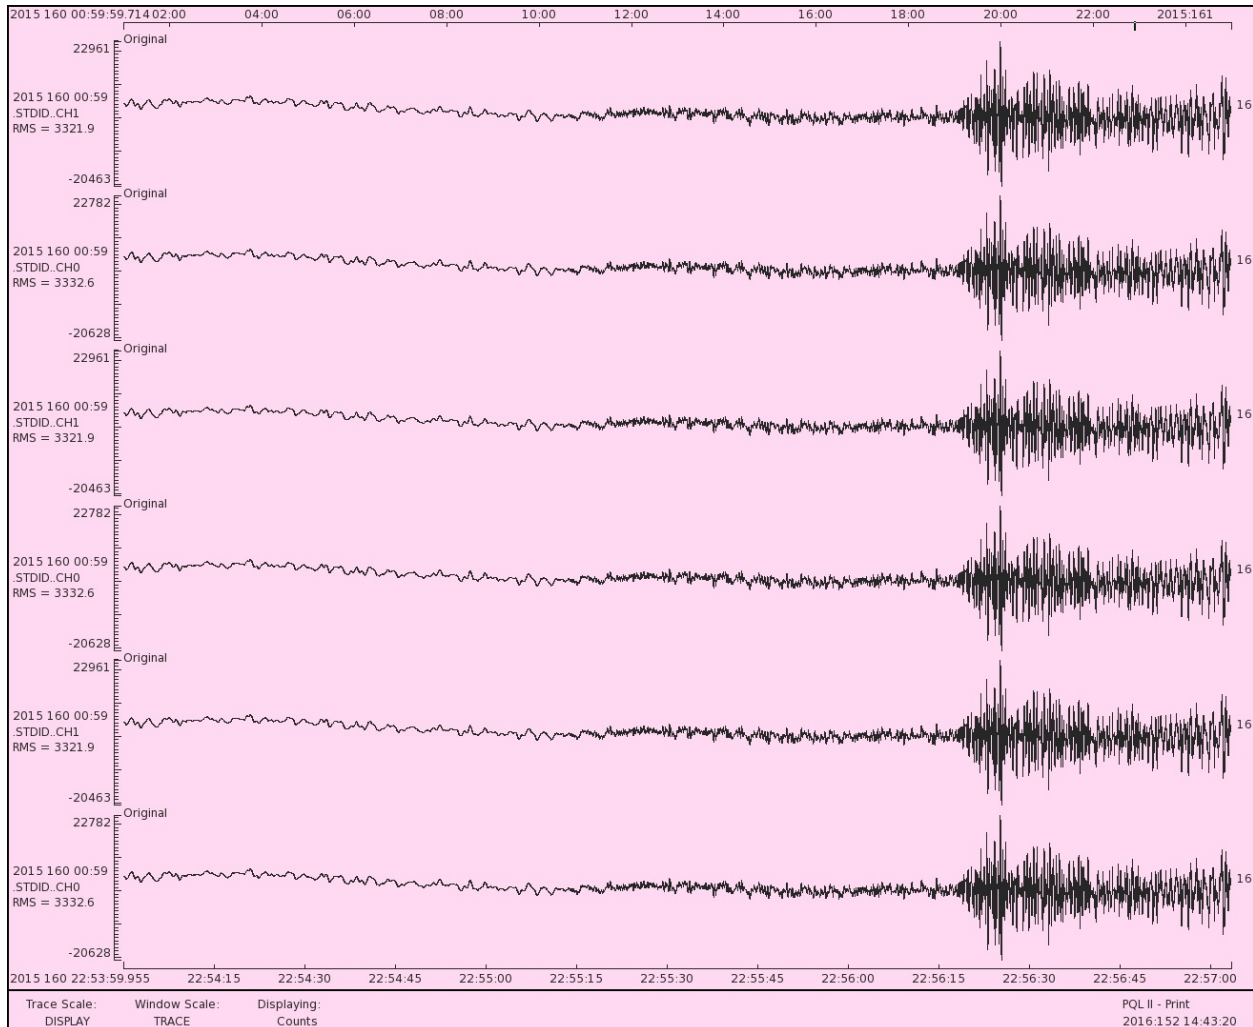
Malawi-site110B-2015-160-reprocess-comp.jpg:

- Bottom two traces → original field data
- Middle two traces → reprocessed from RAW field archive
- Top two traces → reprocessed from original CF card

These efforts confirmed that the root of duplicate data could not be traced to data processing or upload efforts.

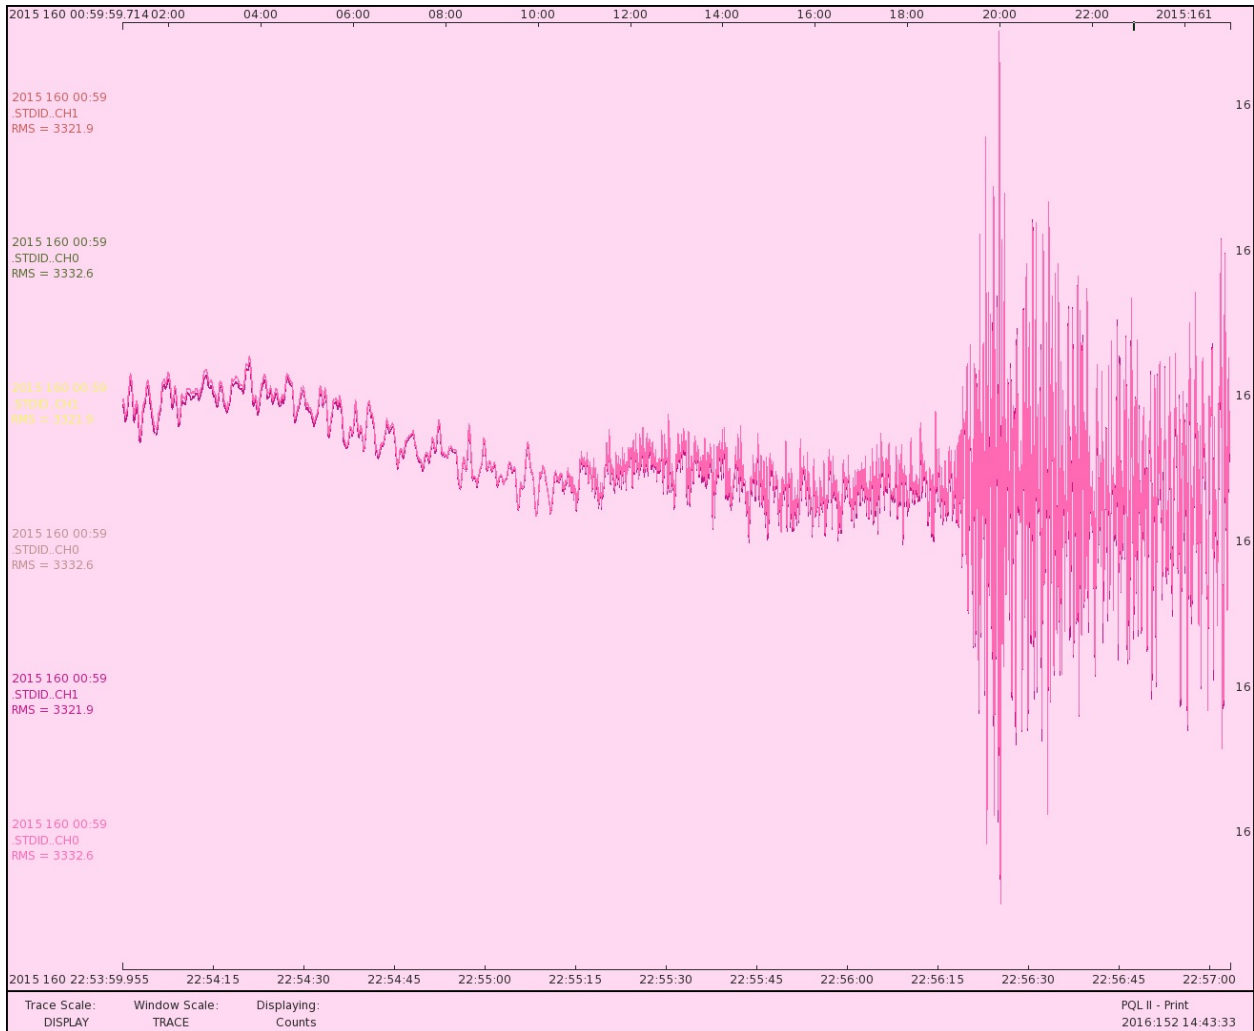
Malawi-site110B-2015-160-reprocess-comp2.jpg: Same data as shown in previous plot with all six traces in overlay mode.

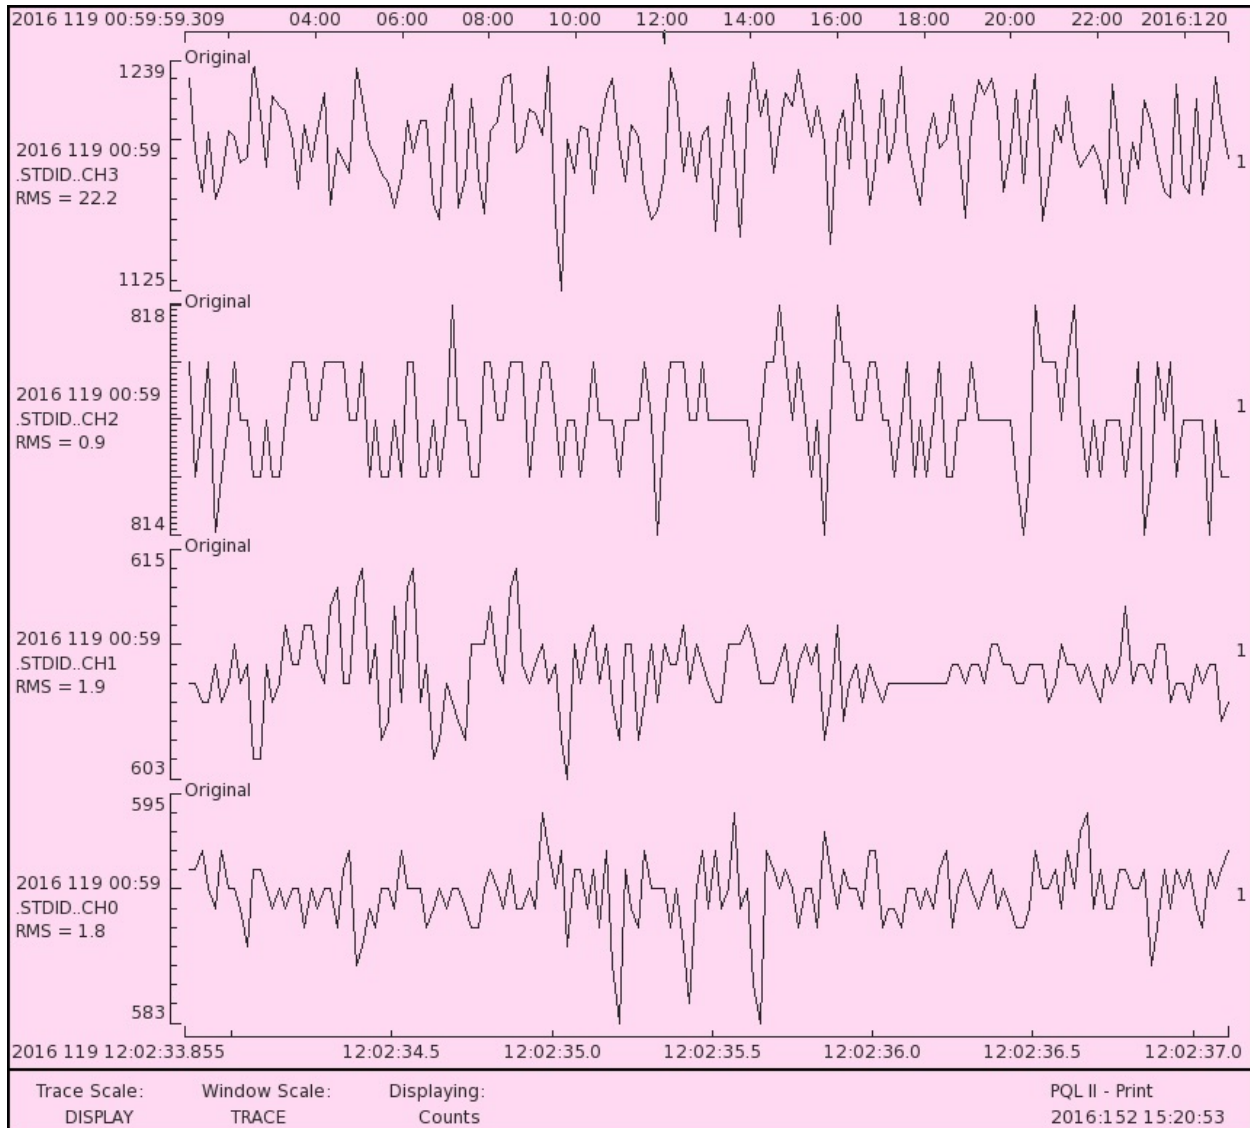
Next, focus turned to datalogger testing and analysis. The question here is whether SIO datalogger 114 (used for Malawi site 110B) produced repetitive data from any the A/D output streams. Logger 114 was set up in a data taking mode in the lab (with an open input) and logged data for ~3-days (see figure below). After inspection of the data it was concluded that datalogger 114 was performing to specification.

LP114-benchttest-data.jpg: All four A/D channels for datalogger 114 showed unique data output.

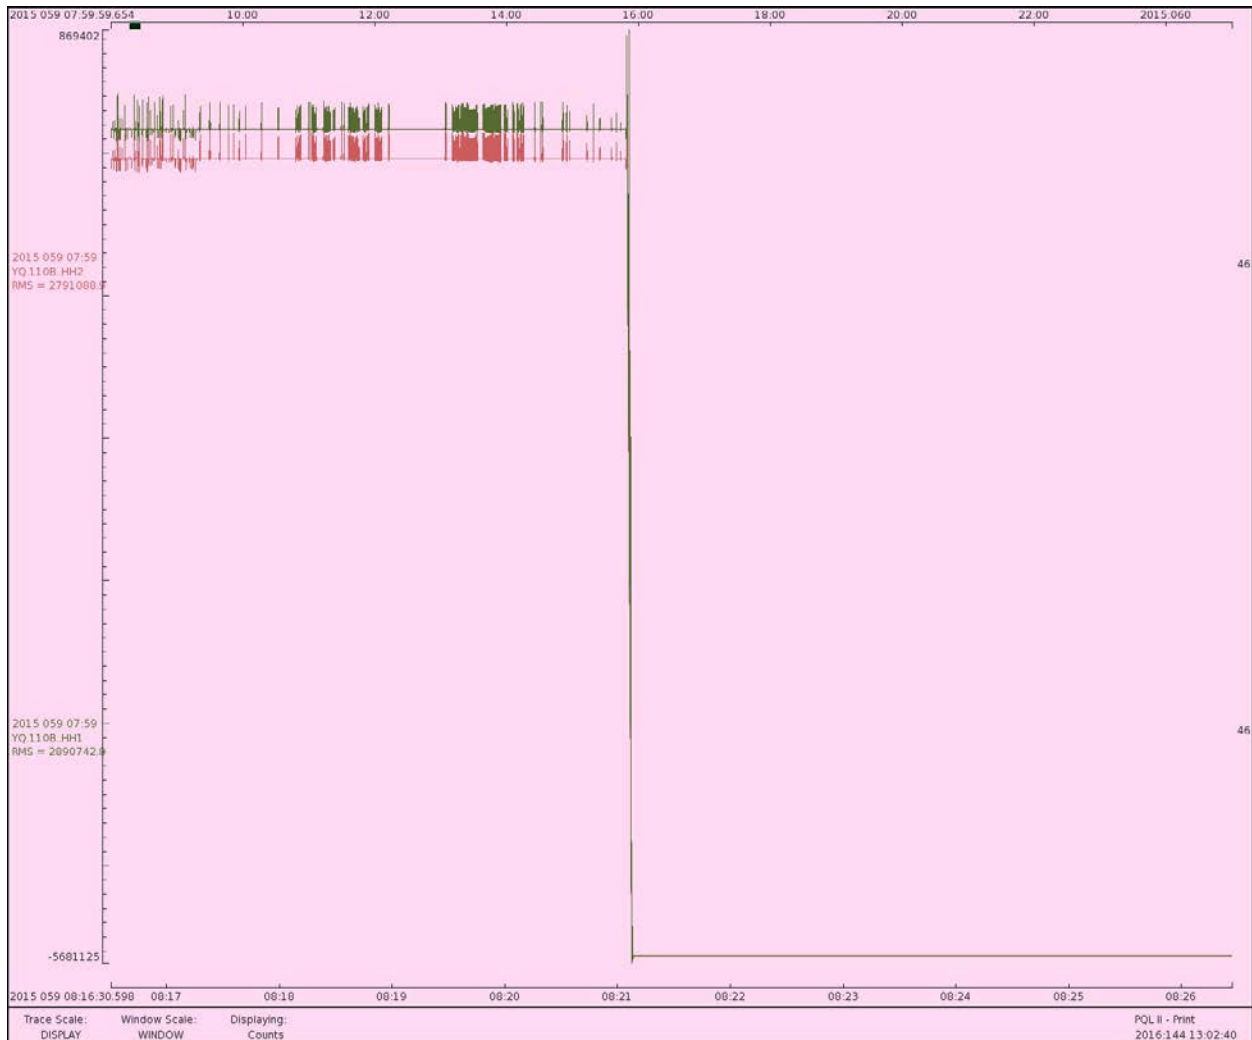
Malawi-site110B-2015-059-horiz-comp2.jpg: First re-level event @ ~2015:059:08:21, which occurred ~2-hours after deployment.

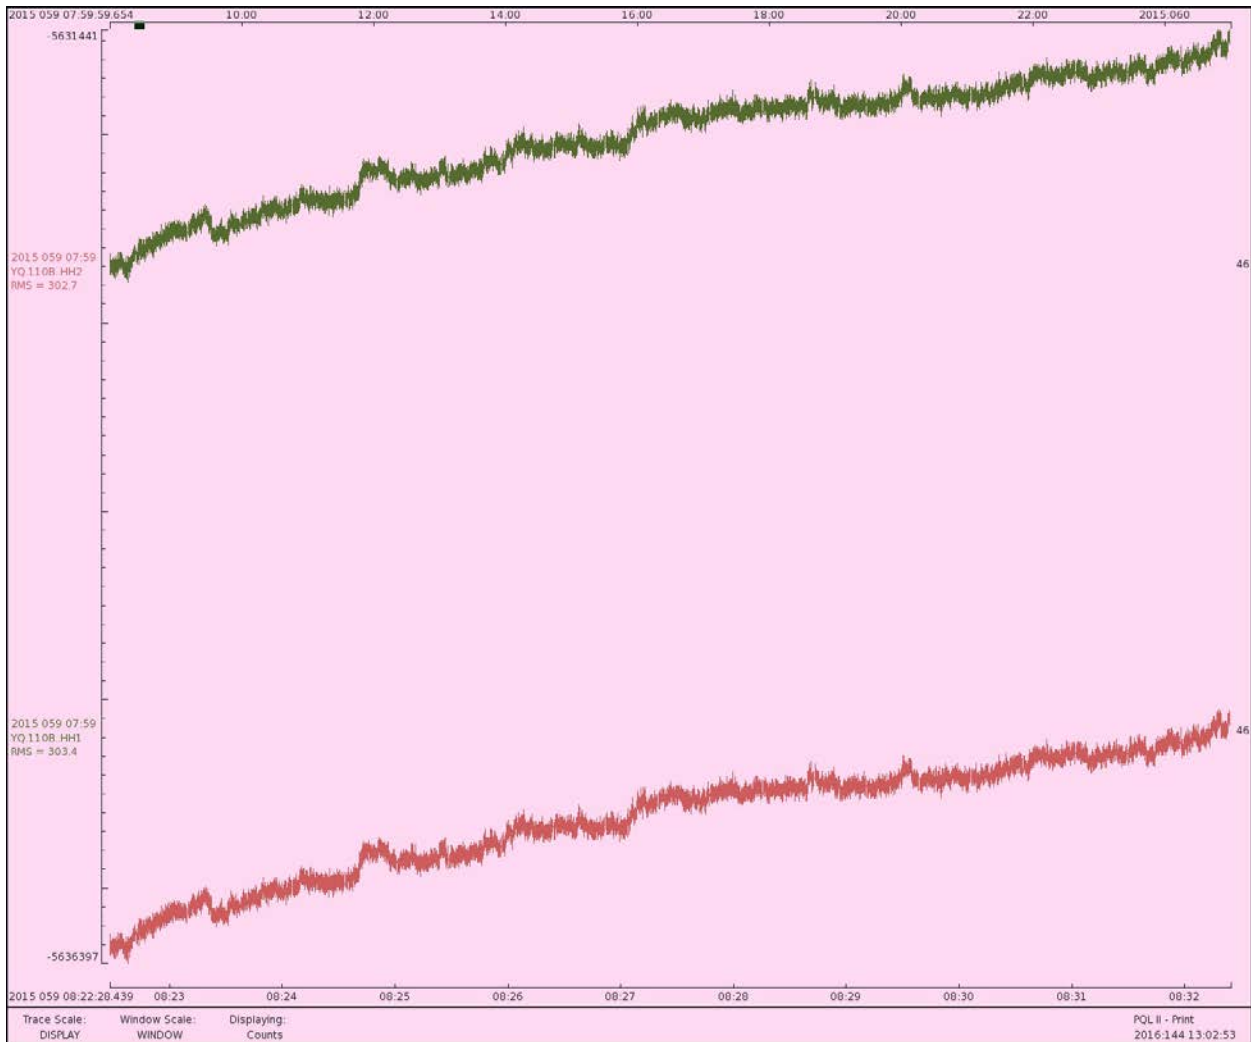
After the initial gimbal/seismometer leveling event the two horizontal channels show nearly identical output characteristics (with an observed DC offset of ~3500 counts).

Malawi-site110B-2015-059-horiz-comp3.jpg: Horizontal channels in overlay mode, ~5-minutes after initial leveling sequence.

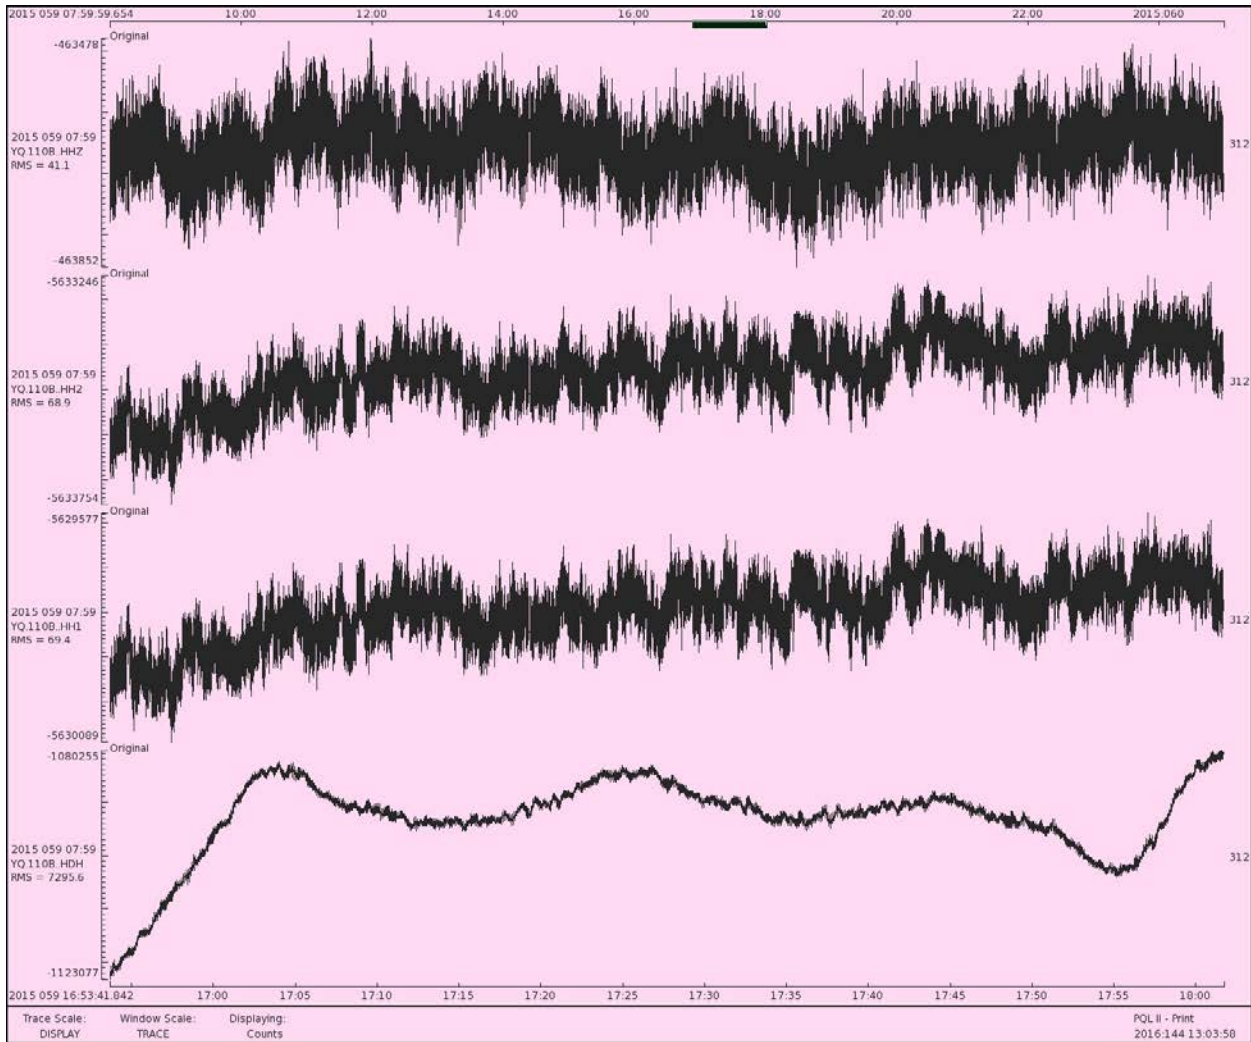
Malawi-site110B-2015-059-all-comp.jpg: Site 110B near day 59 hour 17. Horizontal channels show a similar waveform.

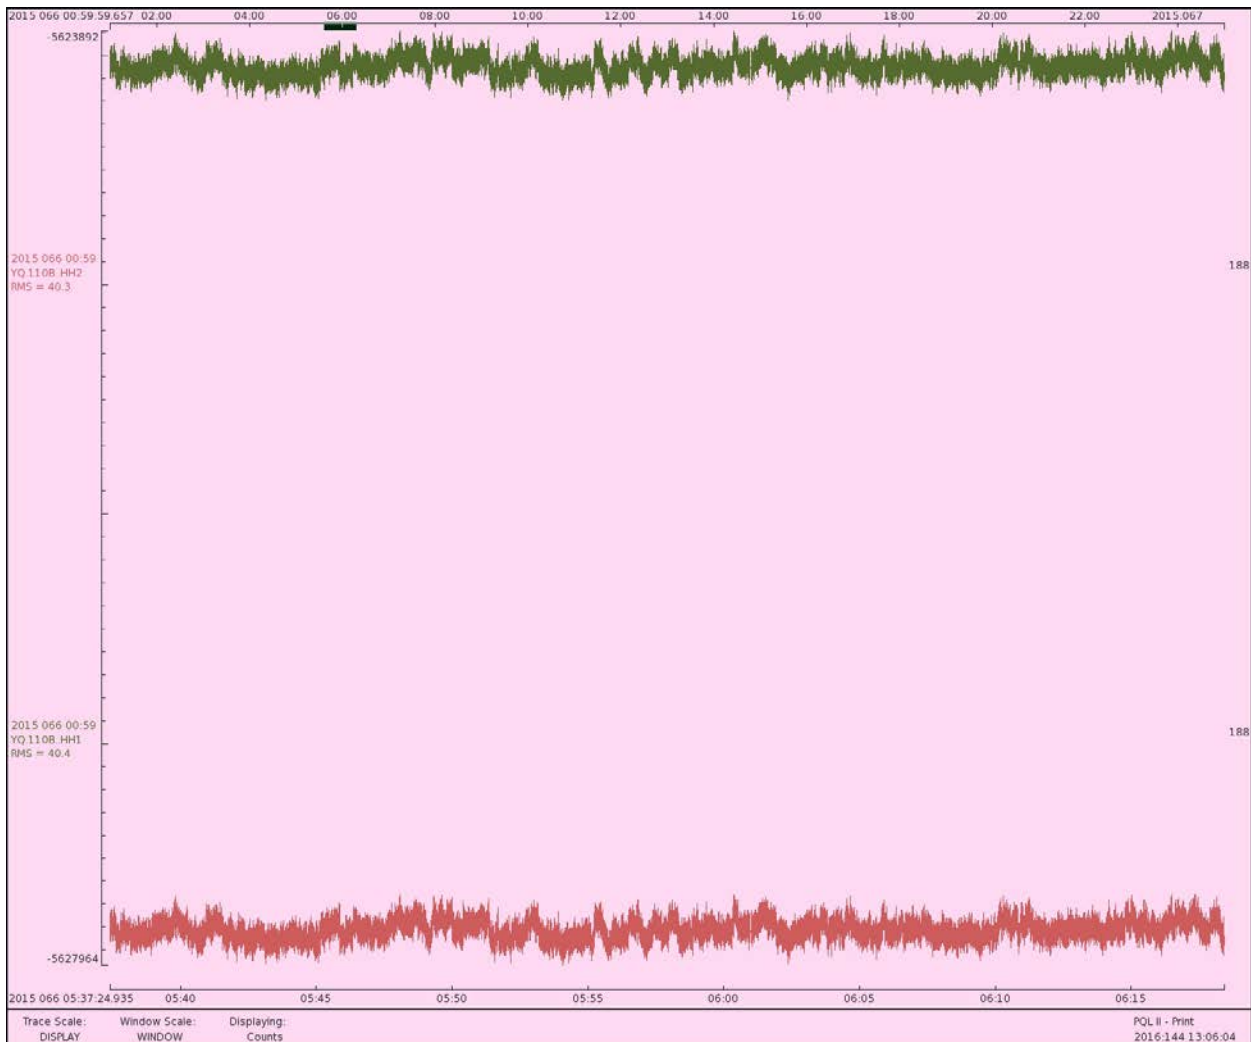
Malawi-site110B-2015-066-horiz-comp1.jpg: Horizontal channel data stream before gimbal recenter event shows the previously observed “identical” output (with DC offset).

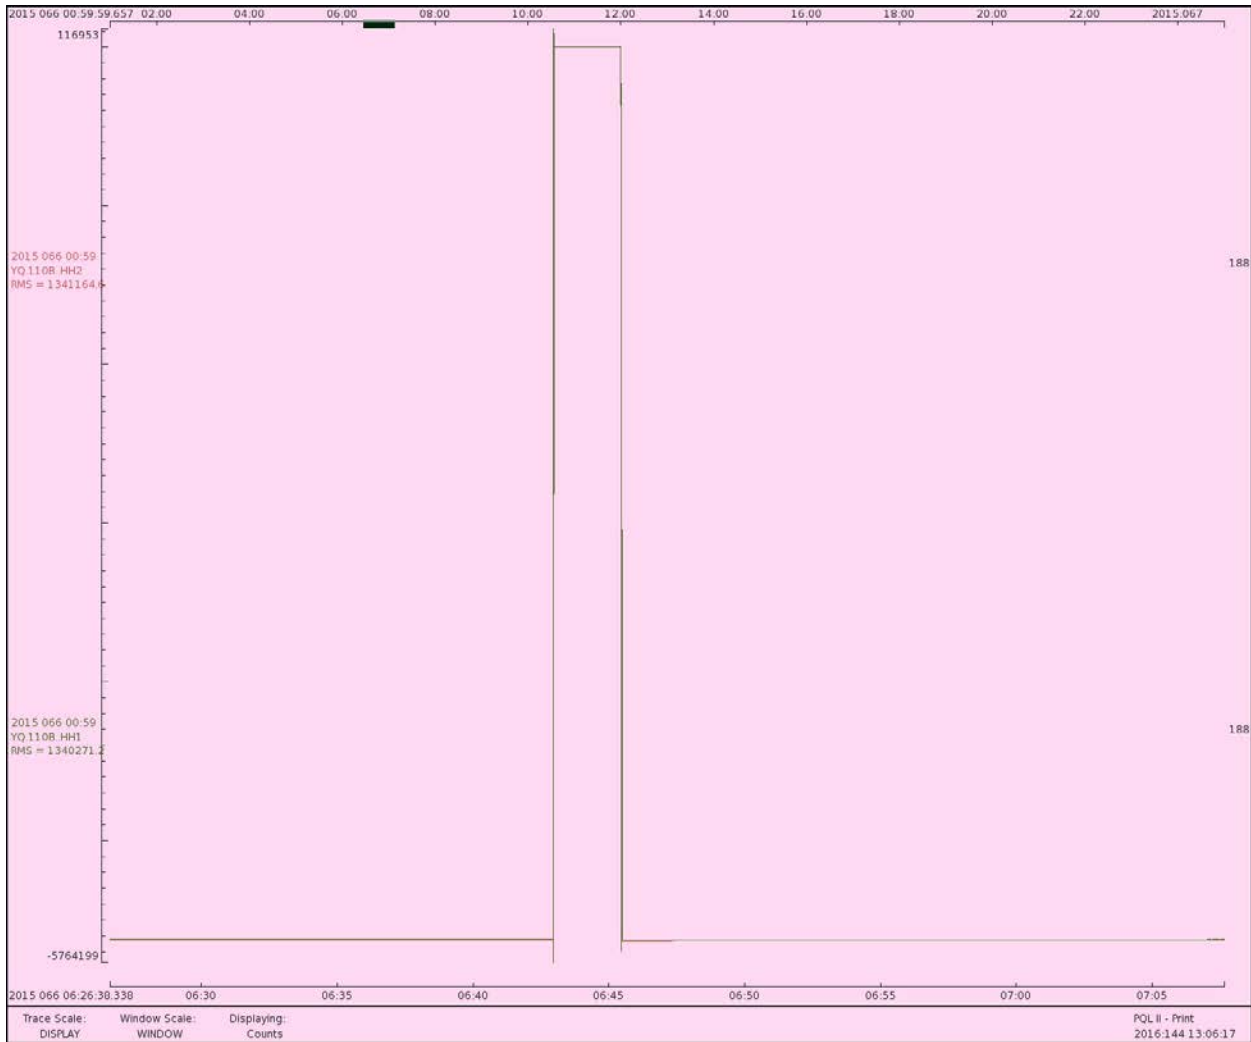
Malawi-site110B-2015-066-horiz-comp2.jpg: Gimbal recenter event near 2015:066:06:43.

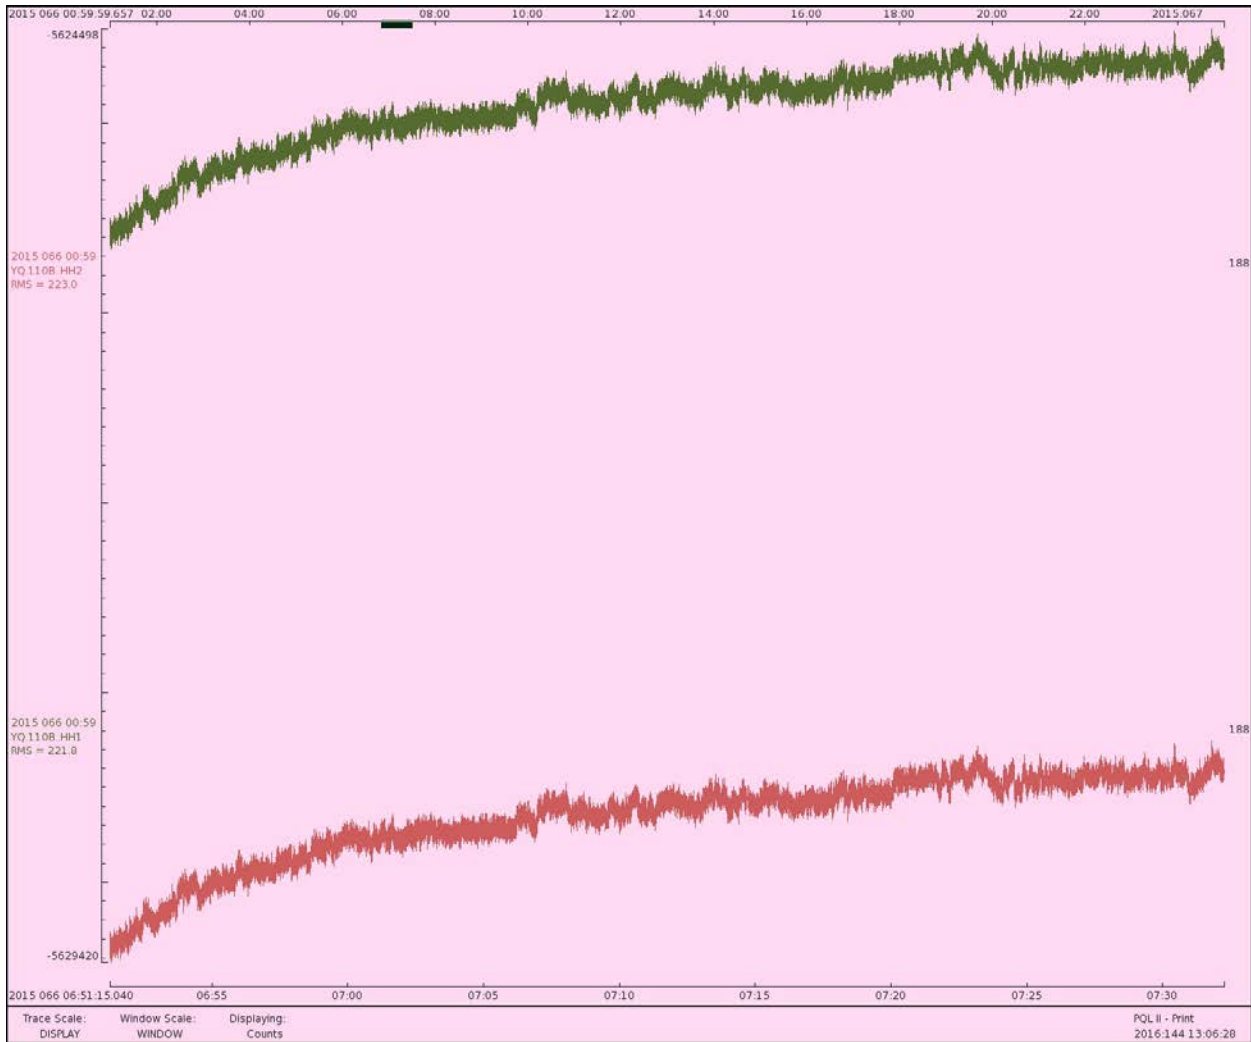
Malawi-site110B-2015-066-horiz-comp3.jpg: Horizontal channel data stream after gimbal recenter event shows the previously observed “identical” output (with ~3500 count DC offset).

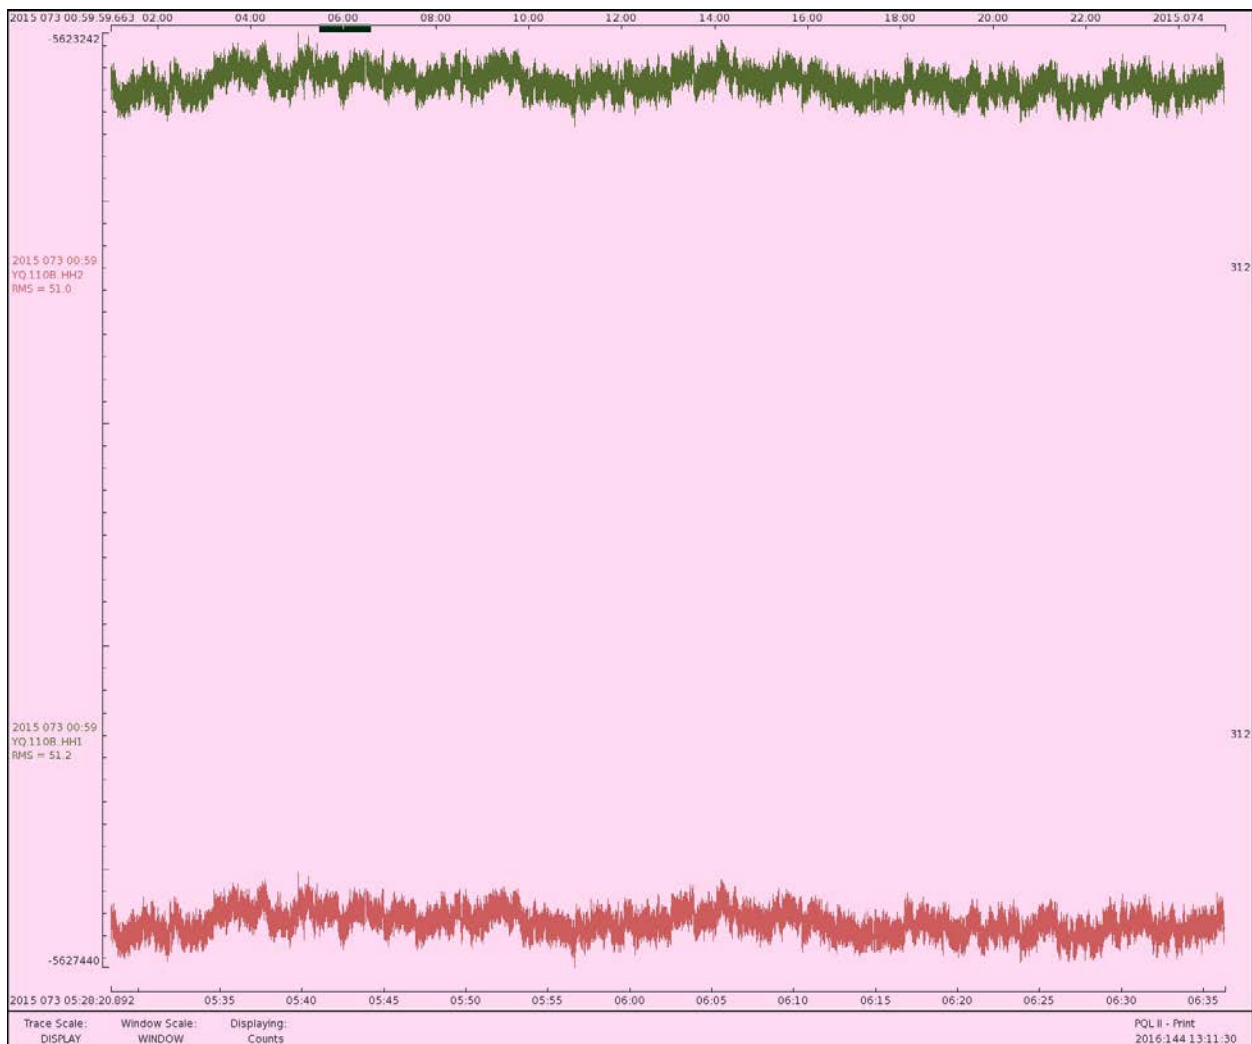
Malawi-site110B-2015-073-horiz-comp1.jpg: Horizontal channel data stream before trillium mass recenter event shows the previously observed “identical” output (with DC offset).

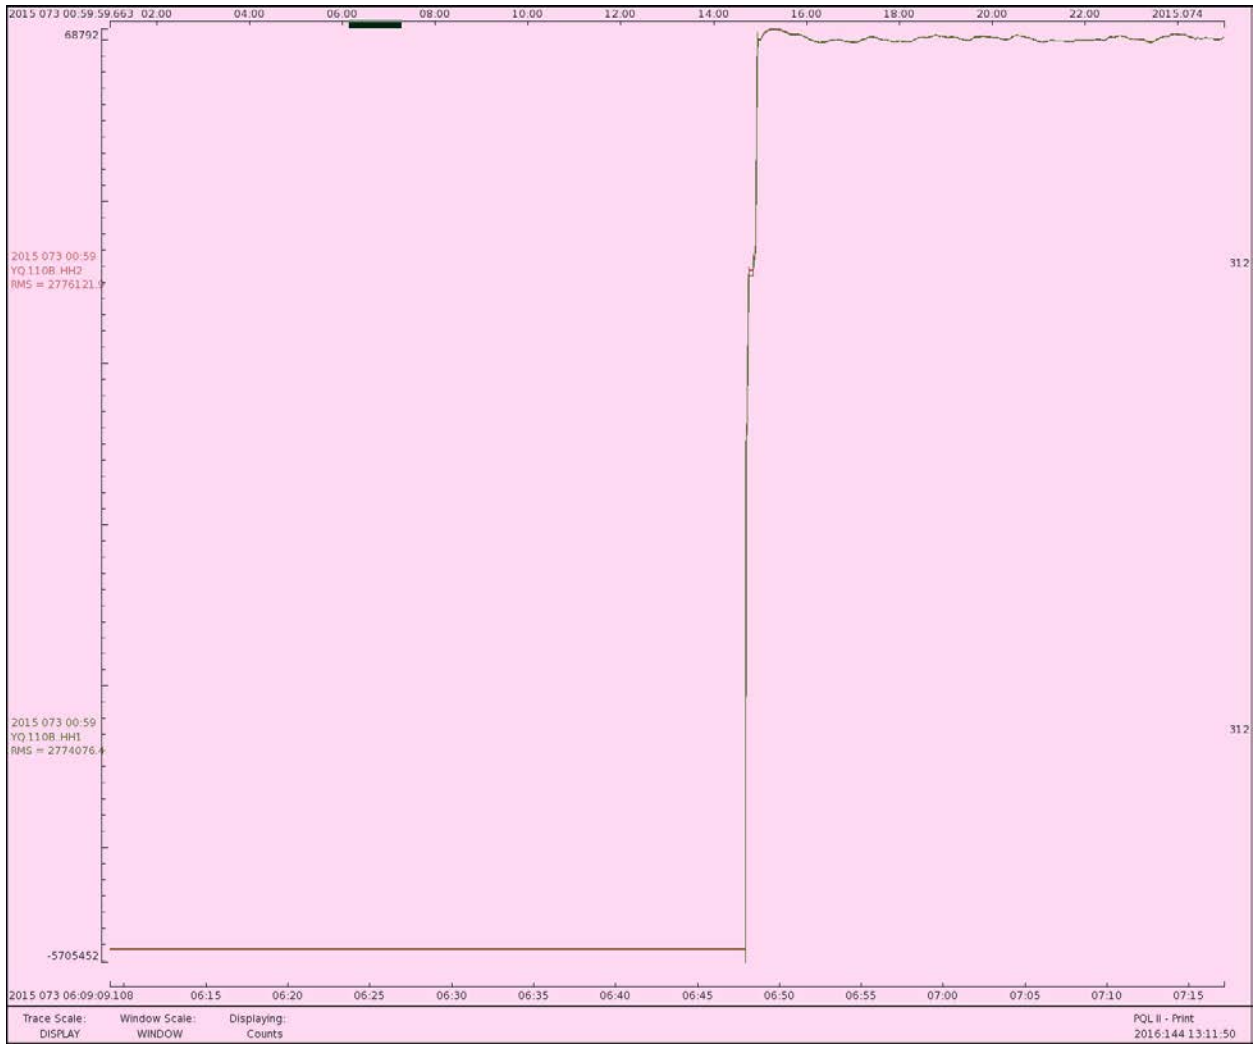
Malawi-site110B-2015-073-horiz-comp2.jpg: Gimbal recenter event near 2015:073:06:48.
