2015 Shilington – Malawi LP4x4 Deployment
Network Code: YQ
Site 110B Data Assessment

Initial observation/assessment:

Sensor-Ball 48 (containing Trillium-240 serial number 145) appears to have duplicating data on the two horizontal channels. Need to test and evaluate SB-48 (T-240 s/n 145) once it returns from Collier-Antilles deployment.

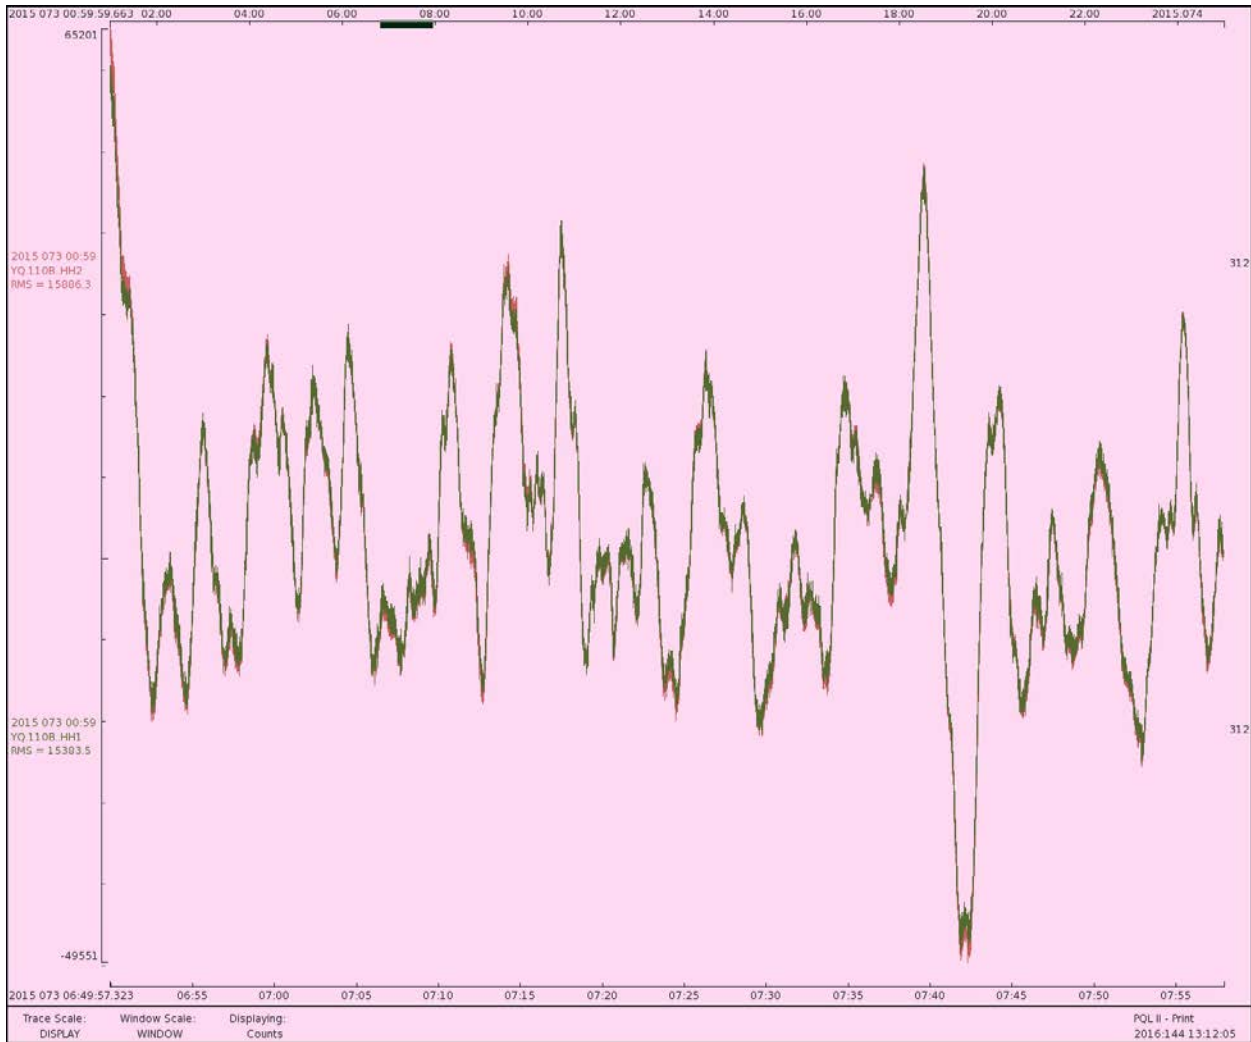
Malawi-site110B-2015-073-horiz-comp3.jpg: Horizontal channel data stream after trillium mass recenter event shows the previously observed “identical” output (with slight DC offset).

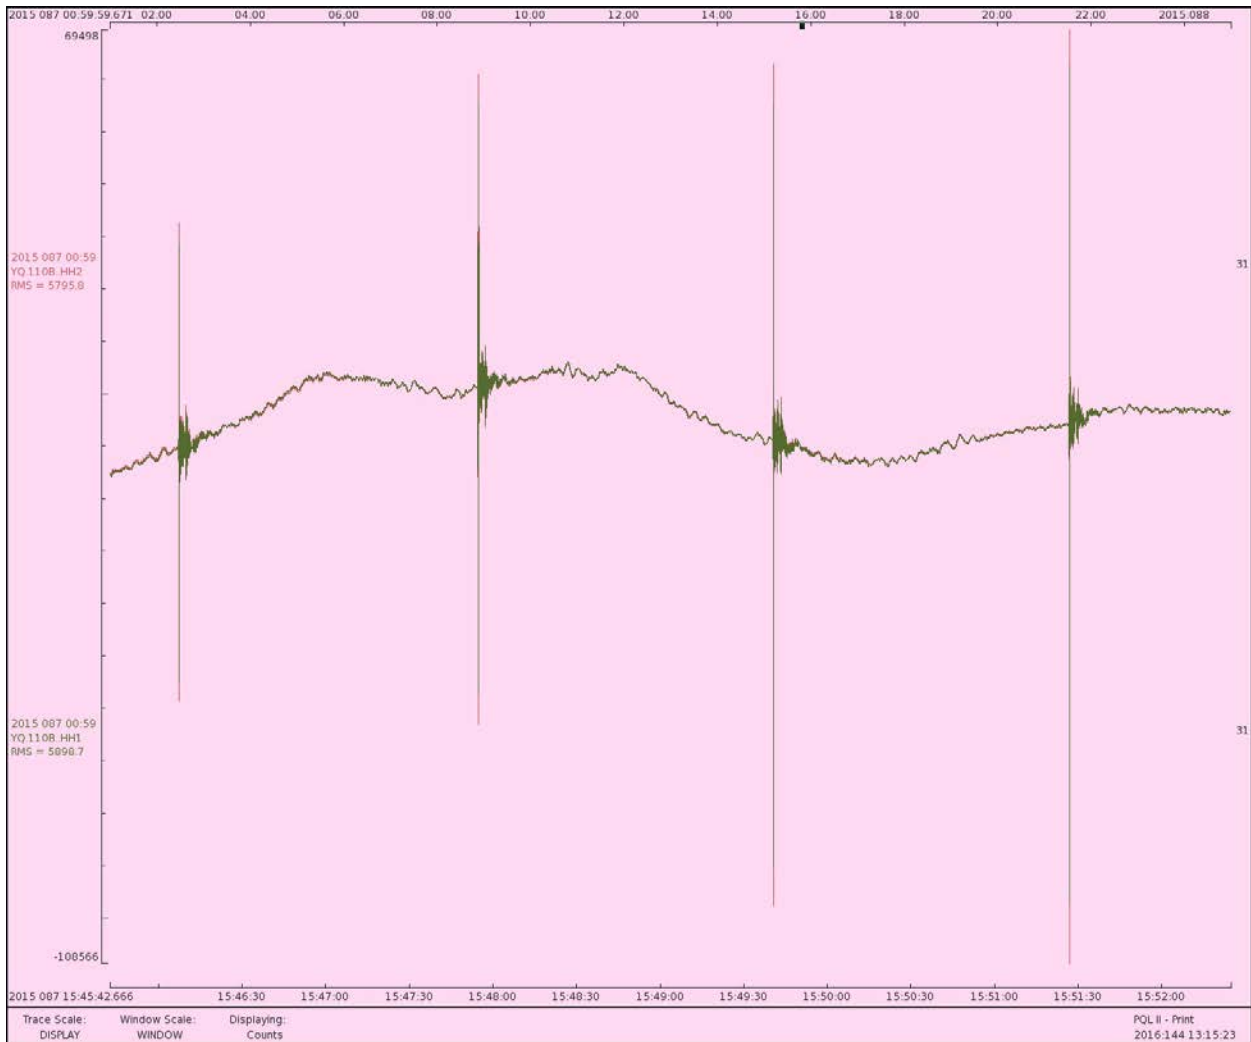
Checking horizontal channel out during shooting phase of experiment again shows “duplicate” output:

Malawi-site110B-2015-087-horiz-comp.jpg: Airgun shots recorded on horizontal channels near 2015:087:15:45.

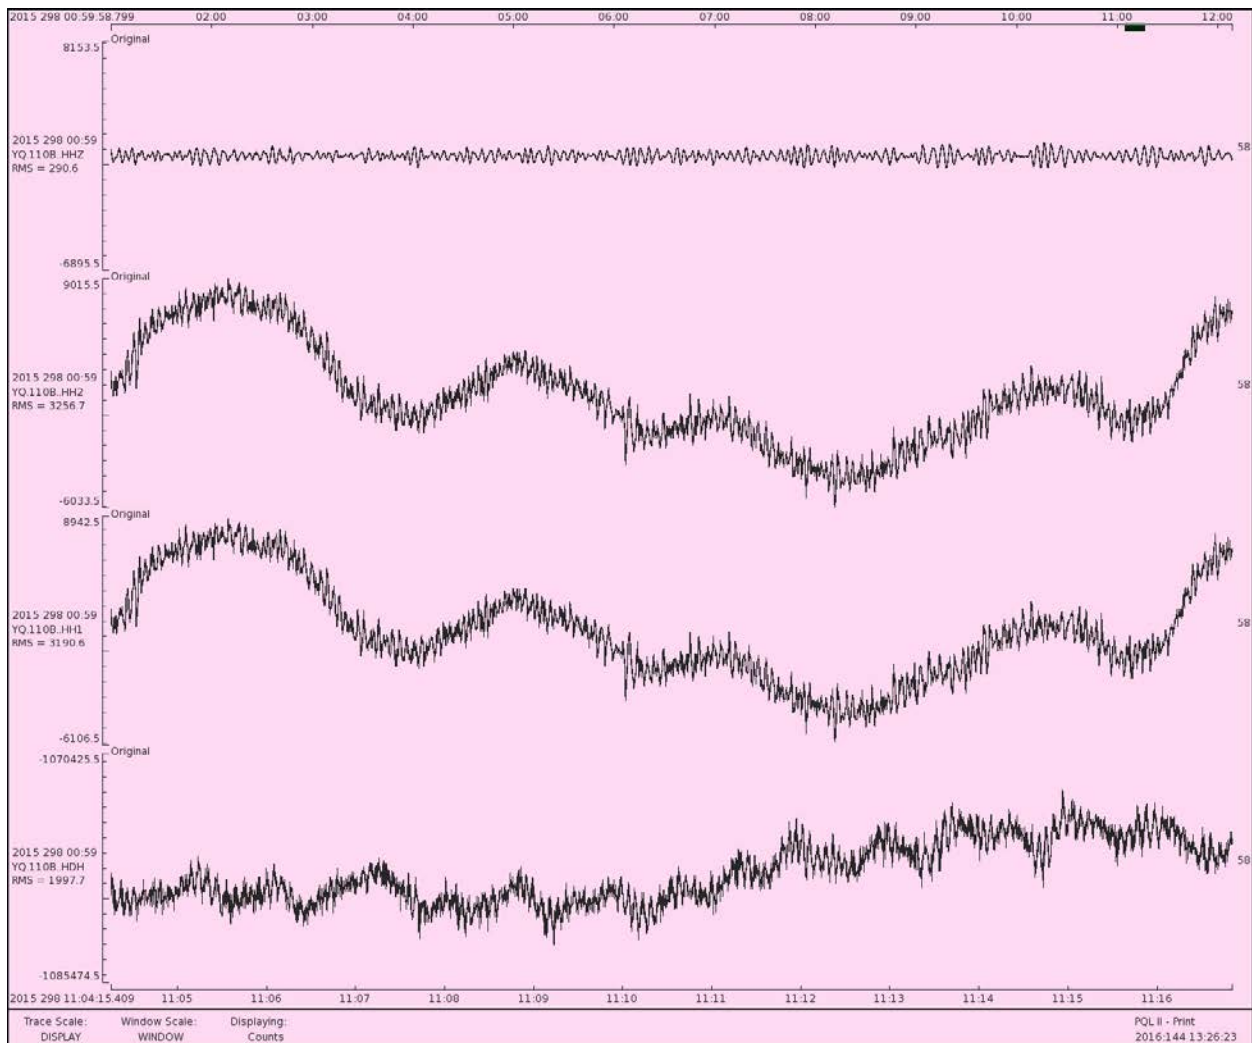
Malawi-site110B-2015-298-all-comp.jpg: Sample data for site 110B near 2015:298:11:05, prior to recovery from the seafloor. The "mirrored" signal in the horizontal channels HH1 and HH2 is still present.

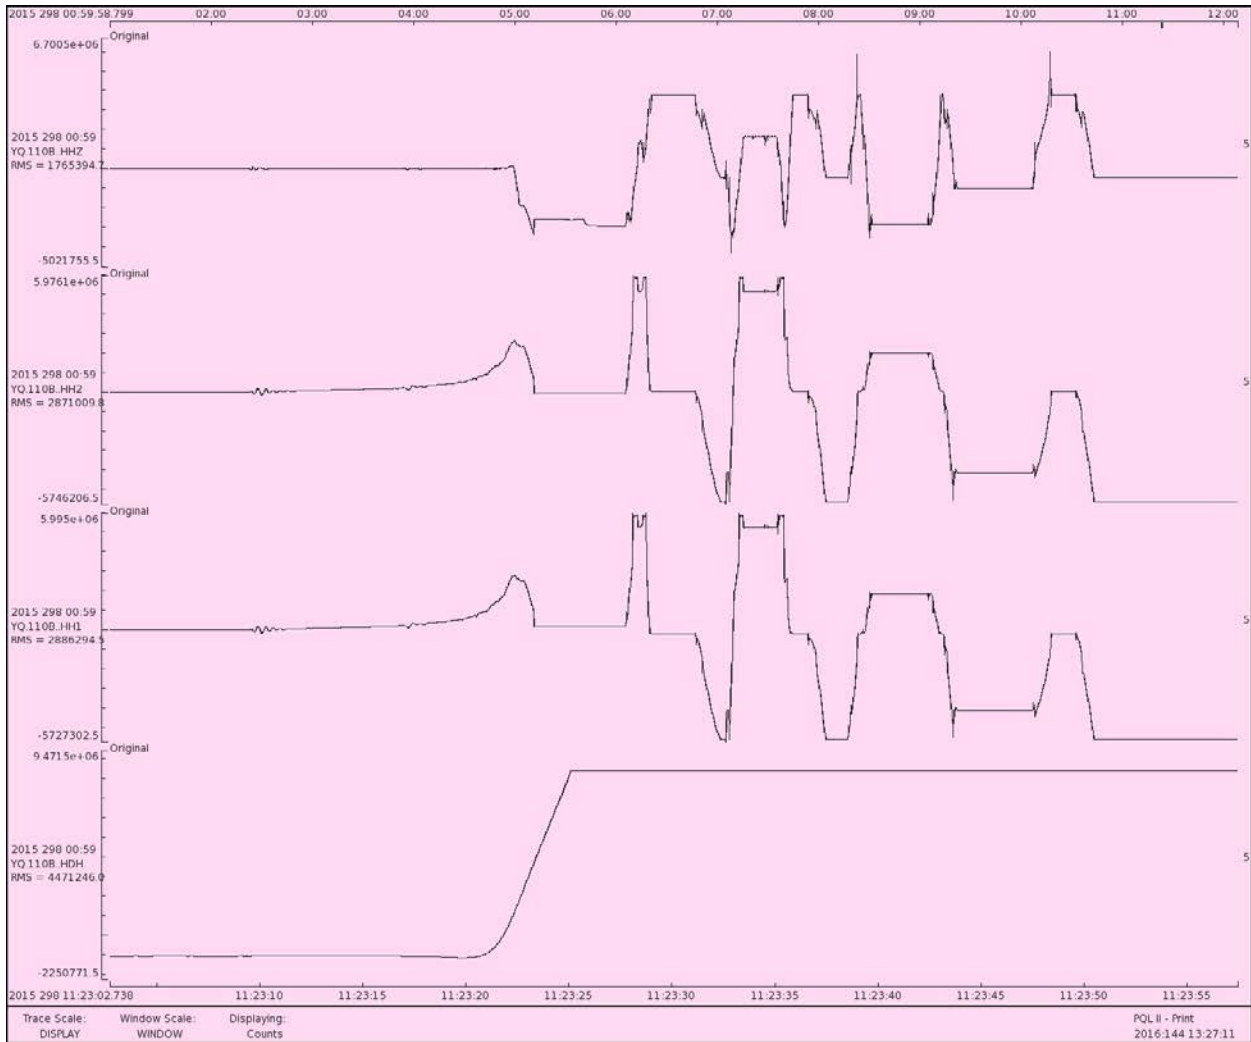
Malawi-site110B-2015-298-horiz-comp.jpg: Polymorph burn cycle completion and lift-off from the lake floor appear to occur near 2015:298:11:23:20.

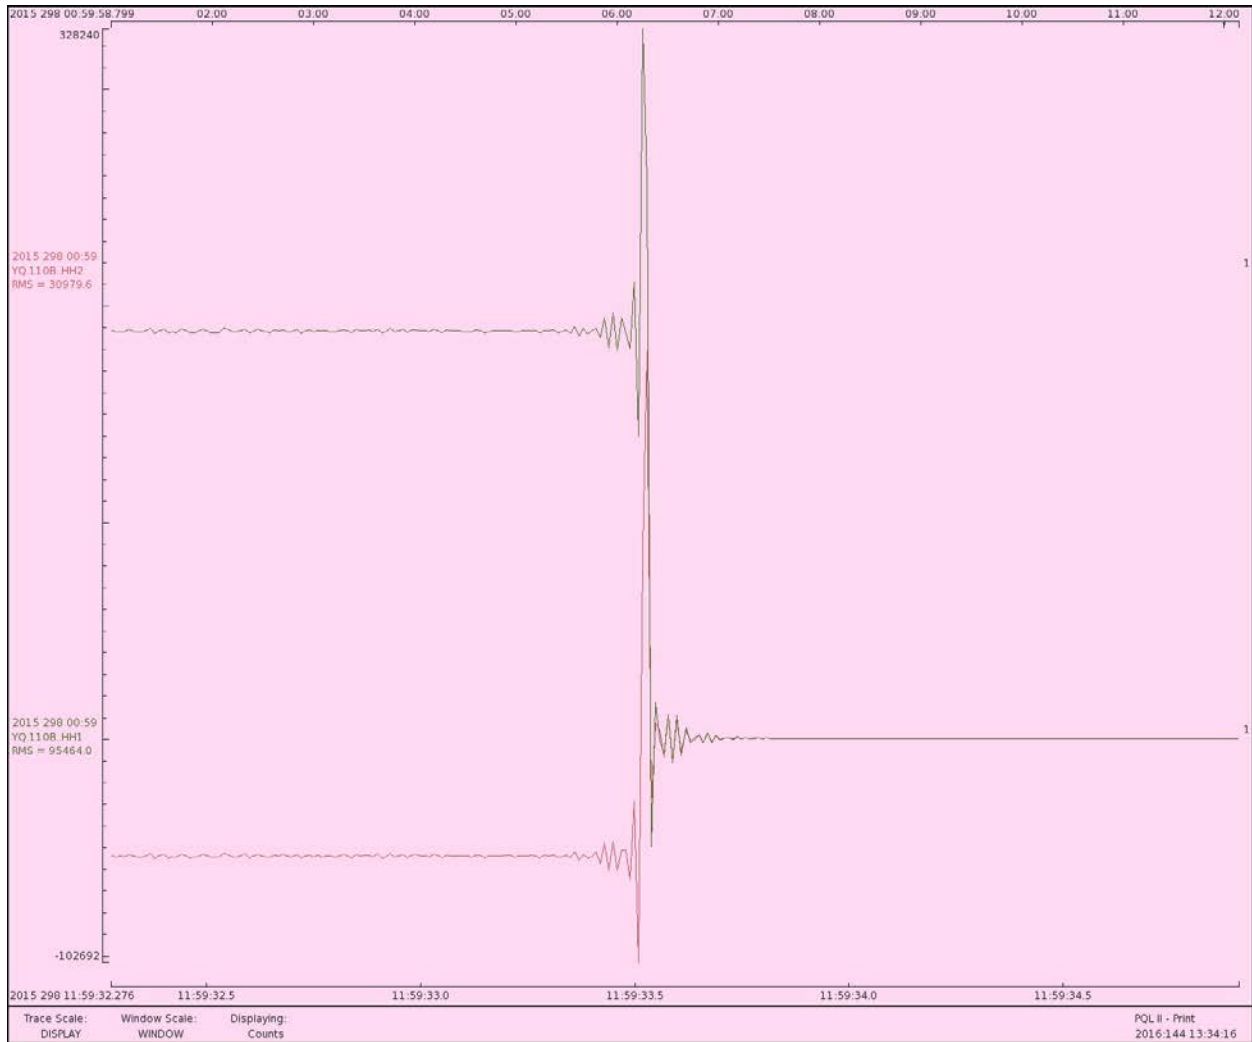
Malawi-site110B-2015-298-horiz-comp2.jpg: With OBS site 110B securely on deck, the sensor ball power/data cable is unplugged near 2015:298:11:59:33.

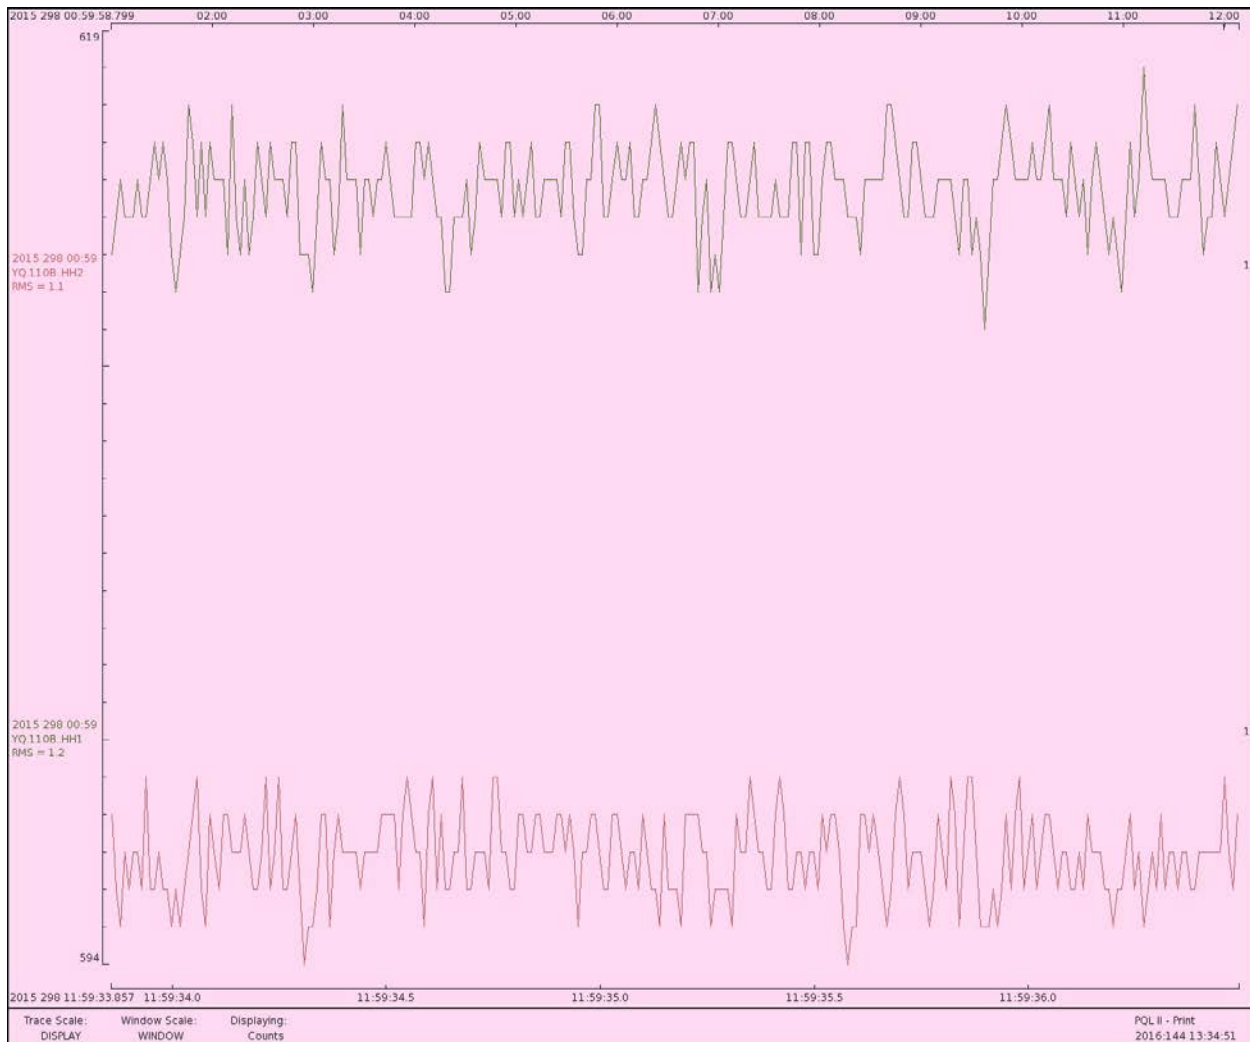
Malawi-site110B-2015-298-horiz-comp3.jpg: Data streams for horizontal channels near 2015:298:11:59, “after” sensor ball power/data cable is unplugged, shows “unique” data streams. At this point the data logger is recording open-ended signal. This suggests that data logger 114 is functioning properly and also implies that the source of the “duplicating” horizontal channel data is coming from sensor ball 48.

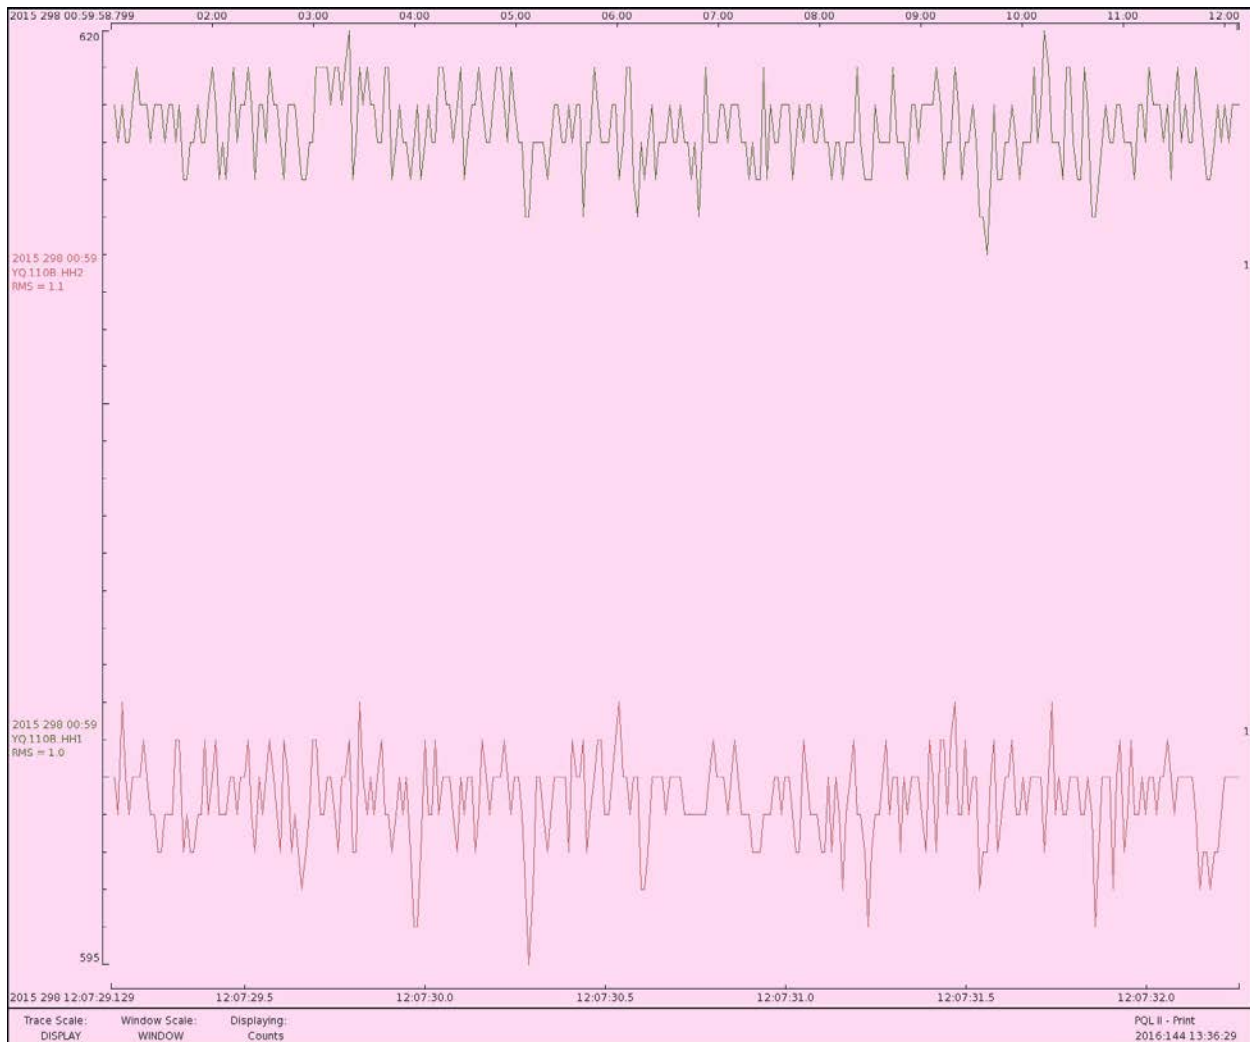
Malawi-site110B-2015-298-horiz-comp4.jpg: Open-ended data recorded near 2015:298:12:07 confirms that data streams for horizontal channels “after” sensor ball power/data cable is unplugged shows “unique” data streams.

At this point the data logger is recording open-ended signal. This suggests that data logger 114 is functioning properly and suggests that the source of the “duplicating” horizontal channel data is coming from sensor ball 48 (Trillium-240 s/n 145).

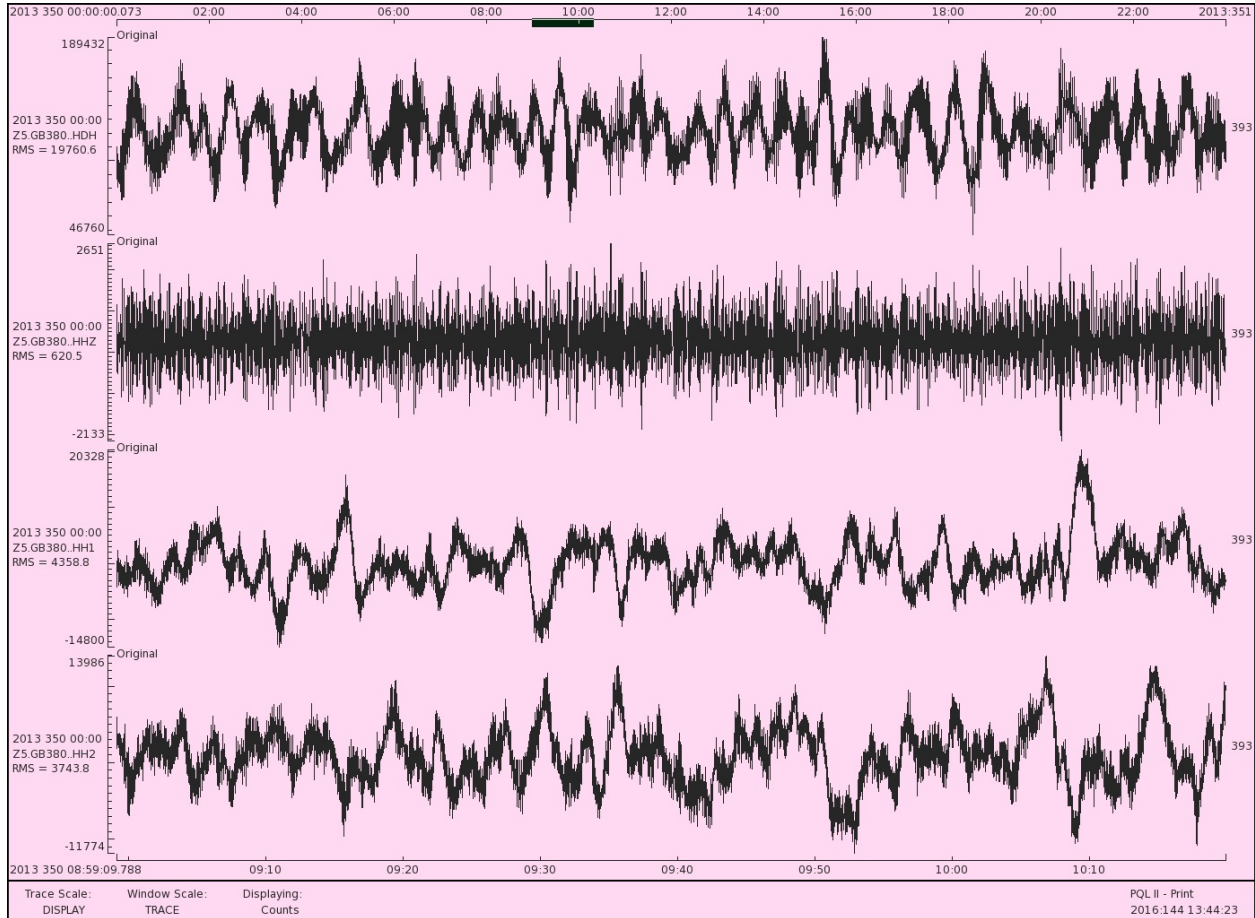
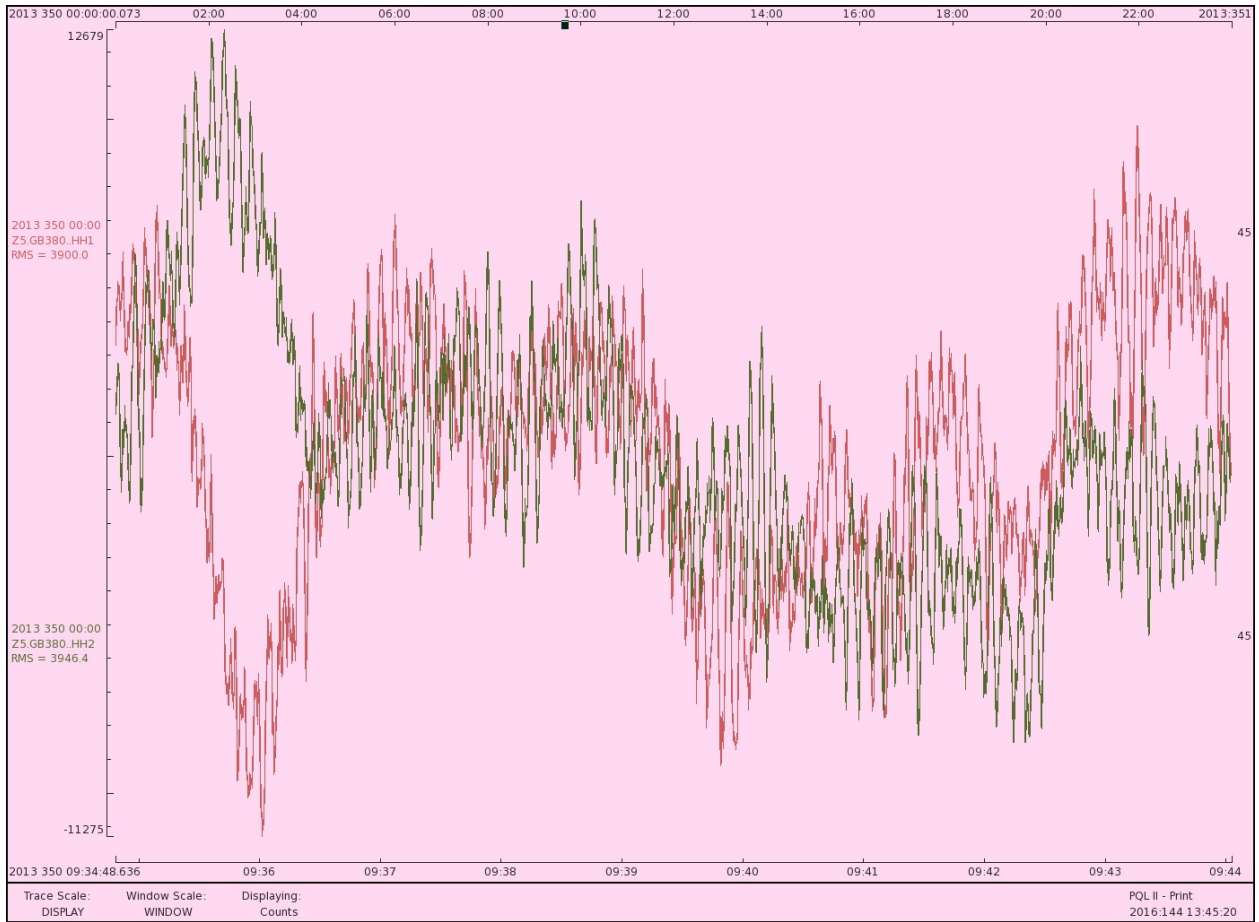
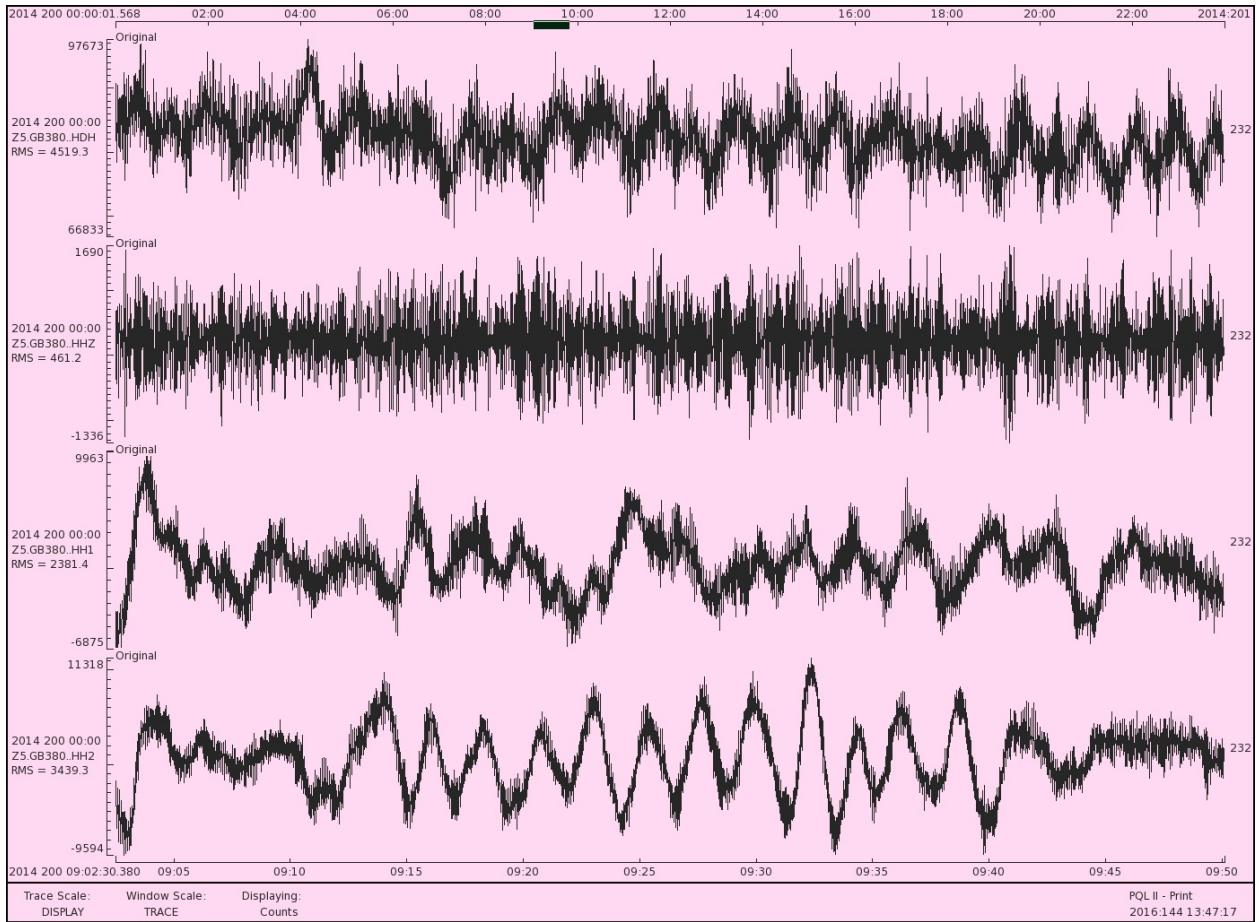
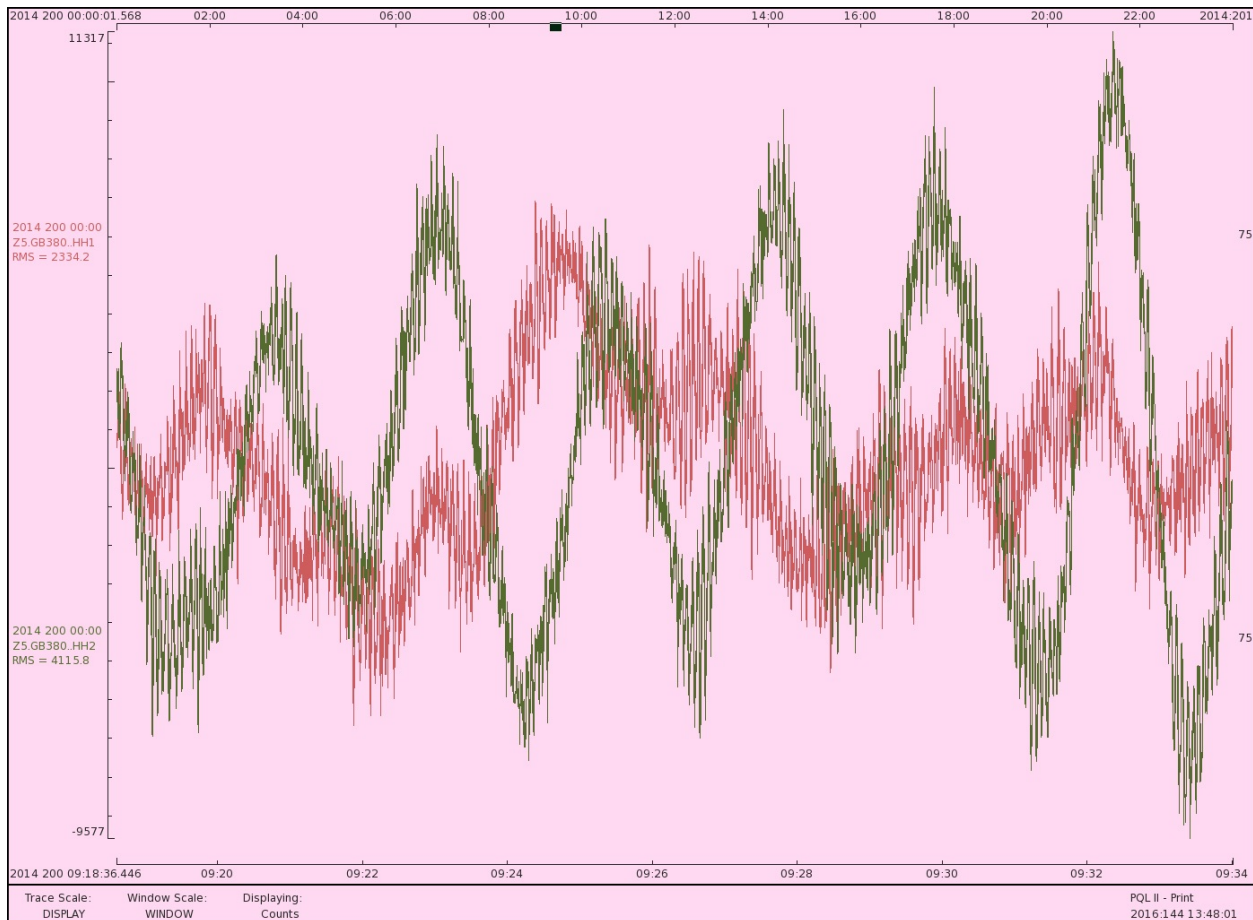
Observations from these select data segments during the Nabelek-Gorda deployment do not exhibit the same “repeating” behavior in horizontal channel data. All data from this previous deployment is “unique” and show no signs of any issues. This suggests that the problem with sensor ball 48 (Trillium-240 s/n 145) could be either new or episodic in nature. Lab testing and analysis of sensor ball 48 wiring and Trillium-240 seismometer s/n 145 will need to be done to isolate the potential source.
